**REQUEST FOR SEALED BIDS  
CONSTRUCTION MANAGEMENT SERVICES**

Davidson Inspection Building Inspection Report (File #25-  
1571)

**Re:** 2250 4th Ave., San Diego, Ca 92101  
Inspection Date: 09/12/2025  
File #-25-1571 4th Ave.

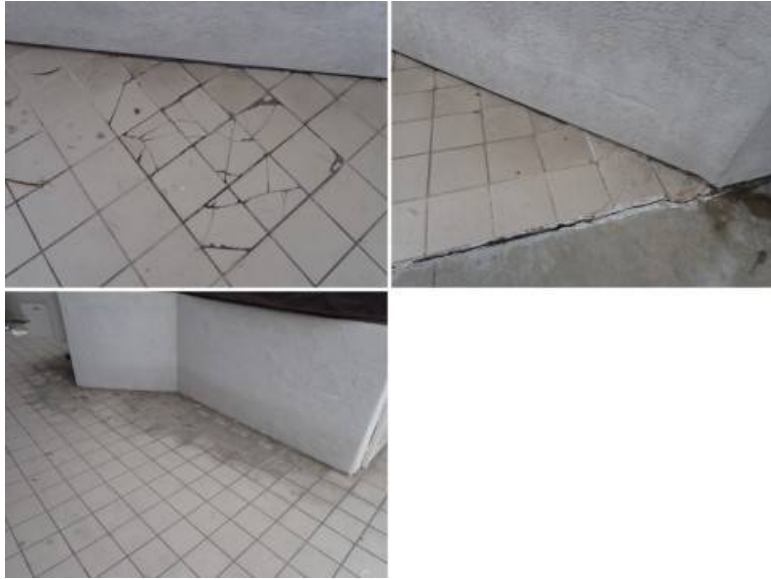
**3.4 Soil Gradient Next to Foundation :**

**Marginal** - Paved surfaces directed surface runoff toward the foundation in various locations and paving is cracked/ damaged/ settled. Paving abutting the structure should not be pitched so that surface runoff collects against the foundation. Corrective measures recommended.

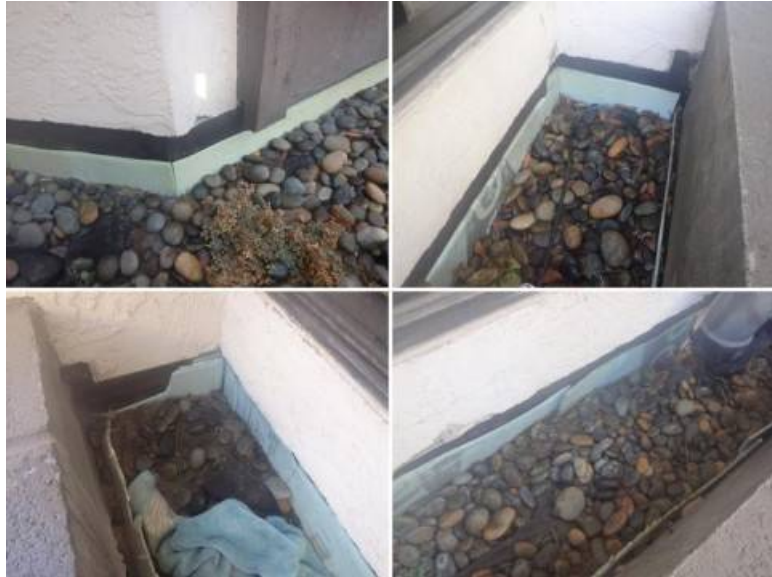
**3.6 Trapped Areas:**

**Further Evaluation** - Surface drainage was blocked / trapped at raised planters. It seems that repairs have been made to the waterproofing system inside the planters. Significant moisture intrusion was present under this area in the basement level suite. We recommend further evaluation by a qualified waterproofing/ drainage specialist to correct this condition. We also recommend a qualified moisture intrusion specialist for further evaluation at this time.

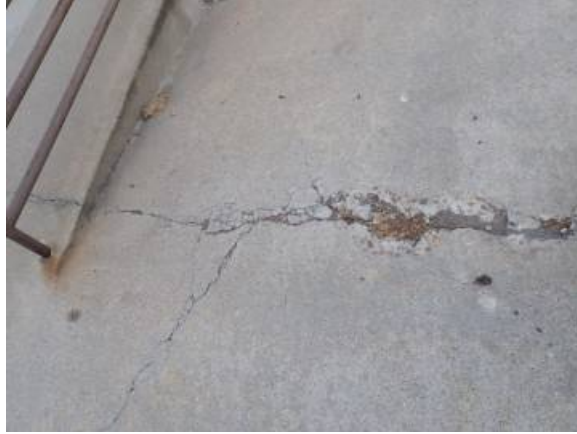
**3.11 Maintenance:**

**Maintenance** - Cracks and gaps in paving should be sealed/repaired at the driveway to stop water infiltration, which can help prevent further damage.

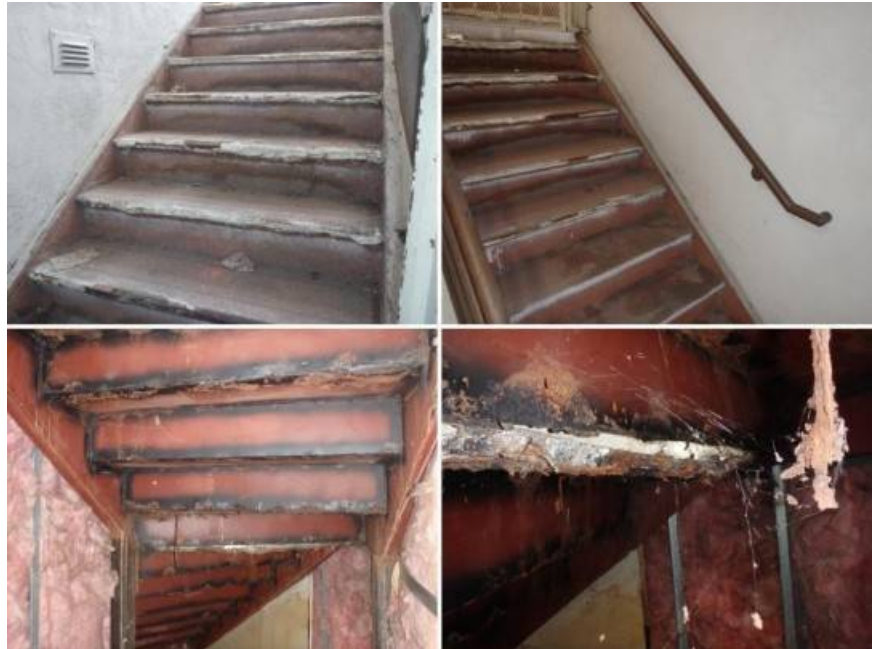
**3.19 Damage:**

**Repair** - Damage/Deterioration was noted to the metal support structure. Storm water has entered this stair well causing damage to the structure. This is the fire escape at the front of the building, so it is very important that this structure be kept in good condition in case of emergency. We recommend further evaluation and correction as needed at this time by a licensed building contractor.

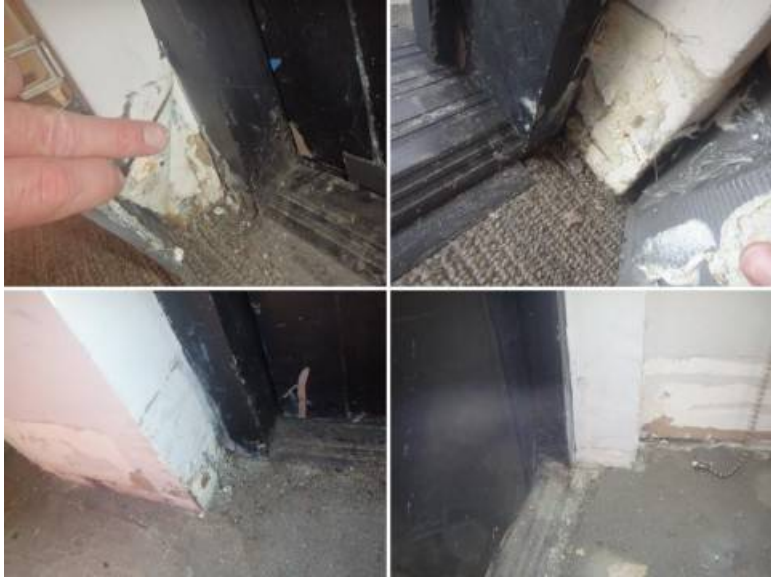
**4.3 Exterior Doors:**

**Further Evaluation** - Water stains and/or water damage was noted at the interior at various doors. There is a concern about moisture intrusion around one or more of the door/window openings. Additionally some deck doors have been caulked at the seams as if a past issue is present with the doors. Sand bags were installed near door openings indicating moisture intrusion issues. We recommend correcting the source as well as any damaged materials.

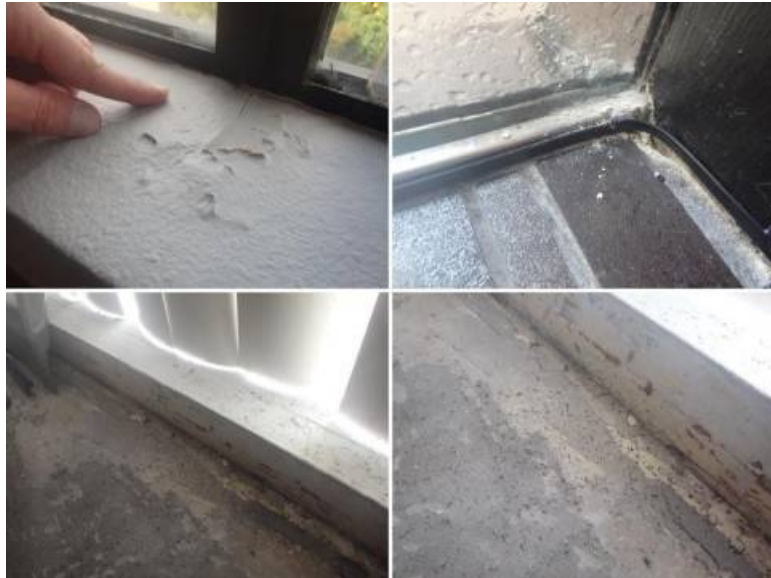
**4.5 Exterior Windows:**

**Further Evaluation** - Water stains and/or water damage was noted at the interior. There is a concern about moisture intrusion around one or more of the door/window openings. We recommend correcting the source as well as any damaged materials.

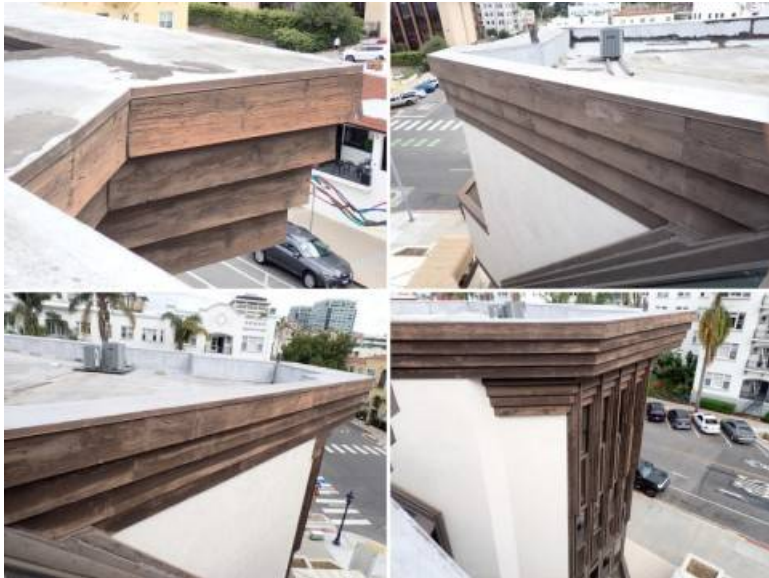
**4.12 Maintenance:**

**Maintenance** - Gaps were noted. Gaps in exterior siding or trim should be sealed/protected to help prevent water infiltration and moisture damage.

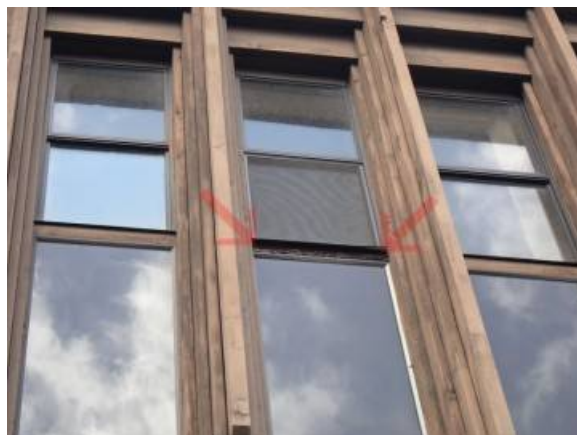
**4.16 Damage:**

**Repair** - Siding was missing. These conditions are conducive to moisture intrusion/deterioration. We recommend correcting the condition(s) noted.

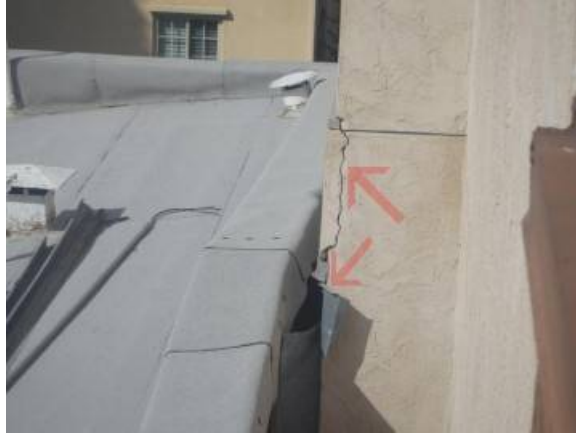
**4.18 Stucco Cracks:**

**Further Evaluation** - Horizontal or vertical cracking was noted to stucco siding. This type of cracking is characteristic of moisture intrusion. Moisture entering behind the siding is often absorbed by the wood framing. The framing swells, which in turn causes the stucco siding to crack, often times along the edges of the framing. Recommend further evaluation and corrections as needed by a qualified siding contractor. Much of the stucco in this area could not be viewed up close.

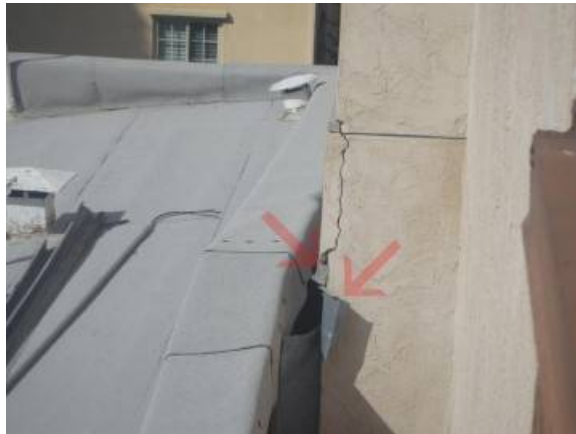
**4.19 Associated Concerns:**

**Further Evaluation** - Incorrect and incomplete flashing was observed at stucco transition flashing. Cracking consistent with moisture intrusion was seen in this area. We recommend further evaluation by a qualified stucco contractor for repairs as needed. Much of the stucco in this area could not be viewed up close.

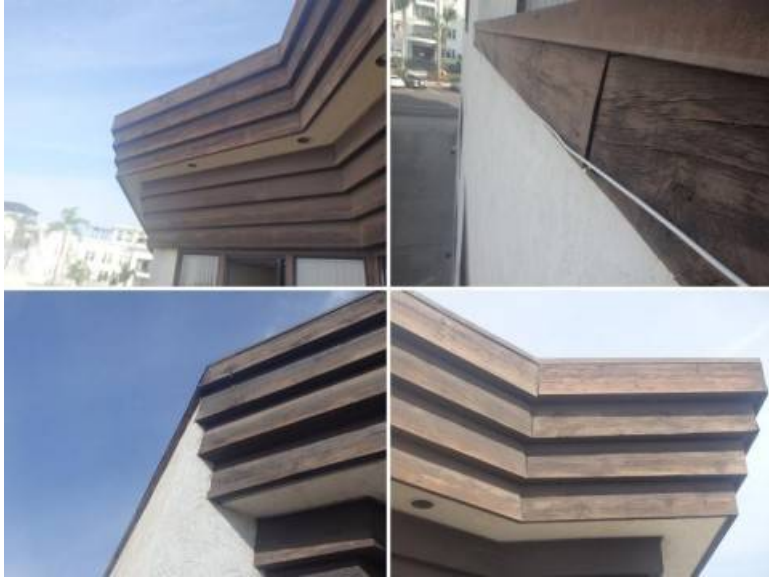
**4.21 Maintenance:**

**Maintenance** - Gaps were noted. Gaps in exterior siding or trim should be sealed/protected to help prevent water infiltration and moisture damage.

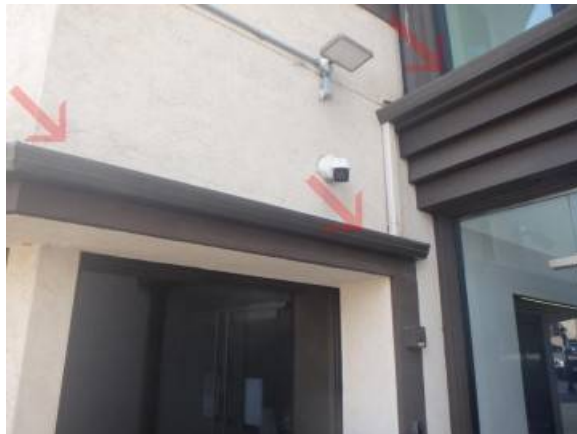
**4.25 Drainage:**

**Maintenance** - Gutters should be cleaned out and correct drainage/ slope verified at this time.

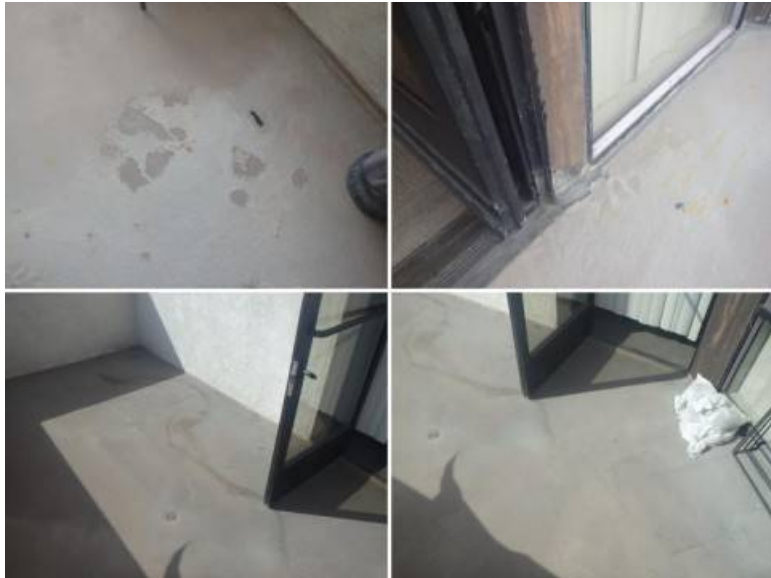
**4.27 Maintenance:**

**Marginal** - Deterioration was noted to the surface coating. It is important to maintain the condition with the deck surface in order to ensure its watertight fitness. Routine maintenance or repair is needed at this time.

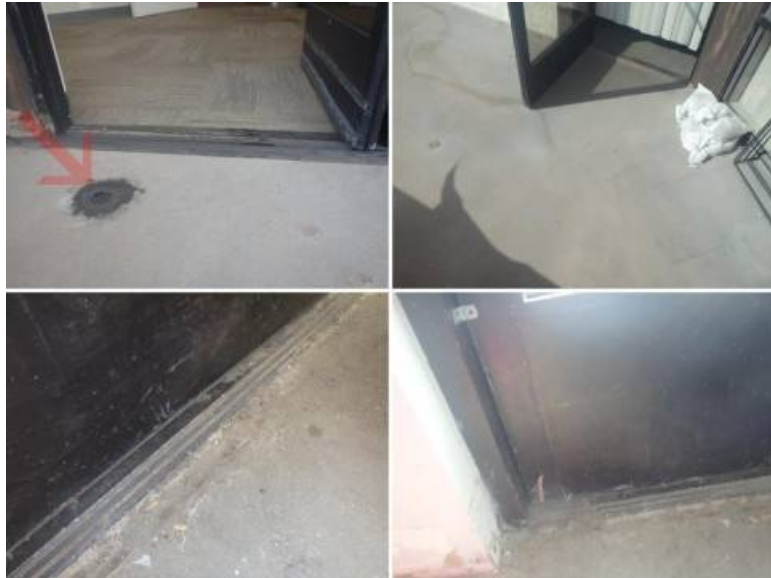
**4.29 Drainage:**

**Further Evaluation** - The exterior grade level of the deck was too high in relation to the interior finish floor and moisture intrusion is evident. Sandbags have been placed on decks in vulnerable areas. The exterior deck surface should be a minimum of 1-1/2" below the interior finish floor to help prevent against moisture infiltration and to properly flash and seal the door threshold. Additionally an added drain was present near a door opening indicating a possible past issue with drainage near this door. A specialty contractor is recommended for further evaluation and corrections as needed.

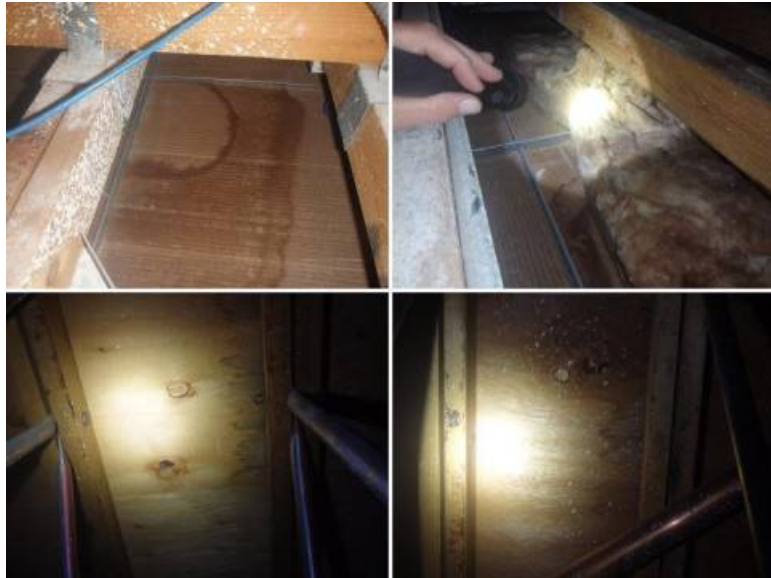
**4.31 Moisture Intrusion:**

**Further Evaluation** - Water stains and/or evidence of patching was observed on the ceiling below the decks. This suggests the deck has leaked in the past. Recommend further evaluation by a qualified specialty contractor.

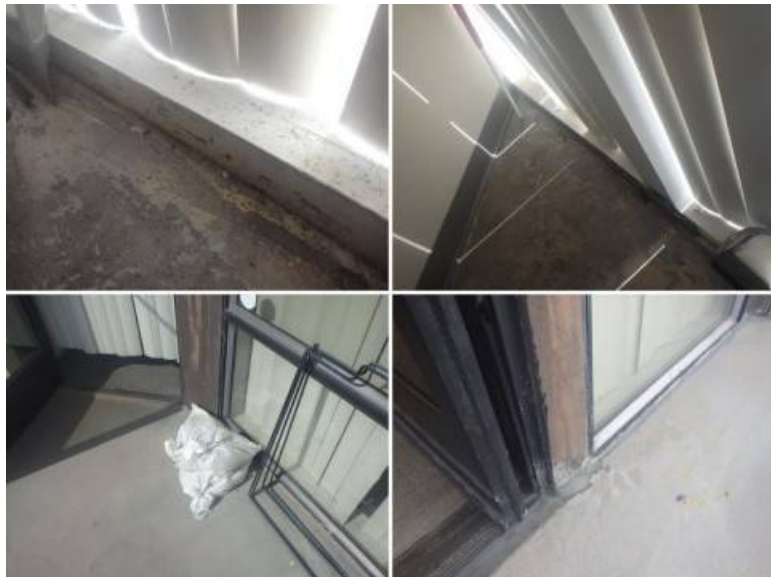
**4.32 Moisture Intrusion :**

**Further Evaluation** - There was evidence of water intrusion from the exterior deck to the interior along deck to wall or window seams. Patches or sealant has been added to the exterior in the past, indicating issues with the deck in these locations. This condition should be evaluated and corrected by a qualified specialty contractor.

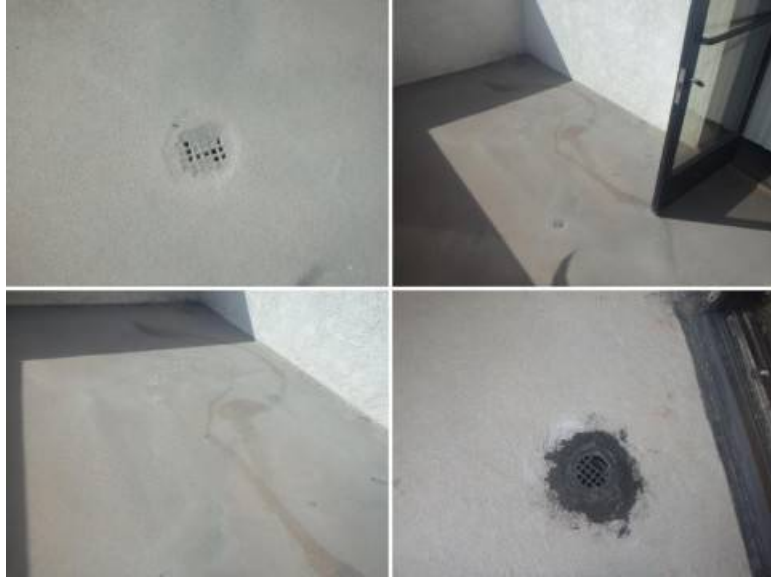
**4.33 Drainage:**

**Marginal** - The deck drains appear to be clogged. This can lead to moisture damage unless corrected.

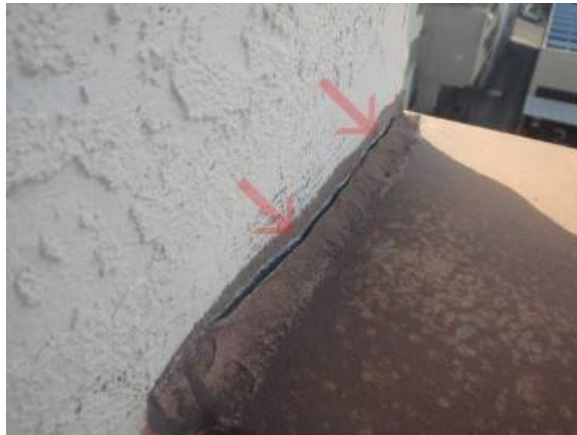
**4.34 Guardrails:**

**Maintenance** - We recommend sealing the guard rail flashing cap ends to prevent moisture intrusion.

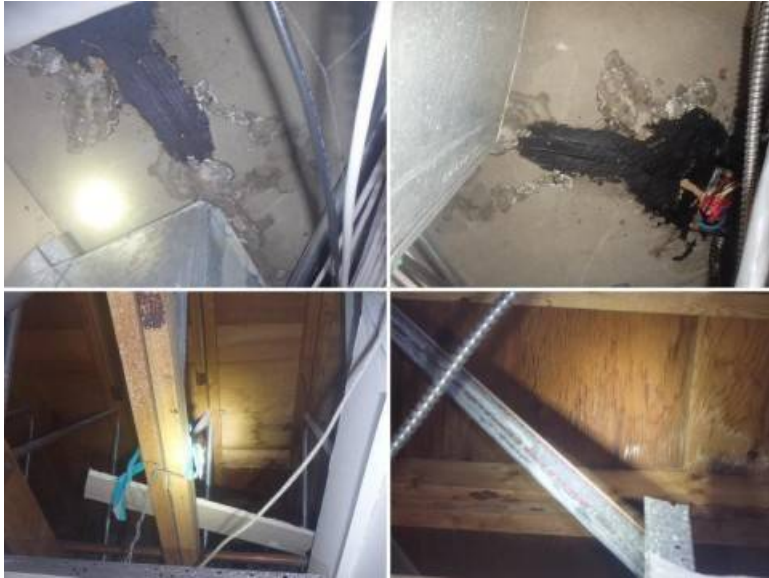
**5.8 Moisture:**

**Further Evaluation** - Excessive water stains noted on framing or sheathing. Moisture intrusion is also present at concrete level(s). Stains are an indication of a past or present leak, which should be investigated further. A licensed pest inspector should evaluate this condition for possible moisture damage.

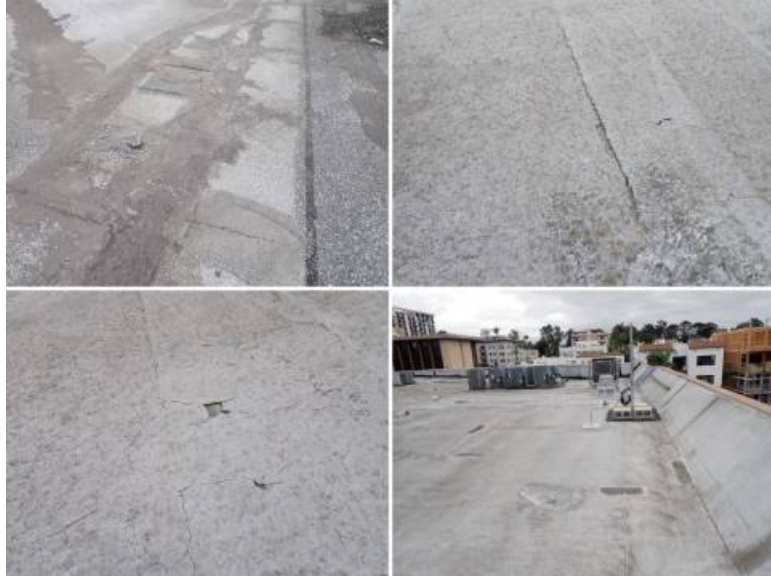
**6.5 Older Roof:**

**Repair** - The roof covering is at end of its useful life. Signs of advanced aging were observed with the roofing material and/or paper underlayment. We recommend replacing the roof covering at this time.

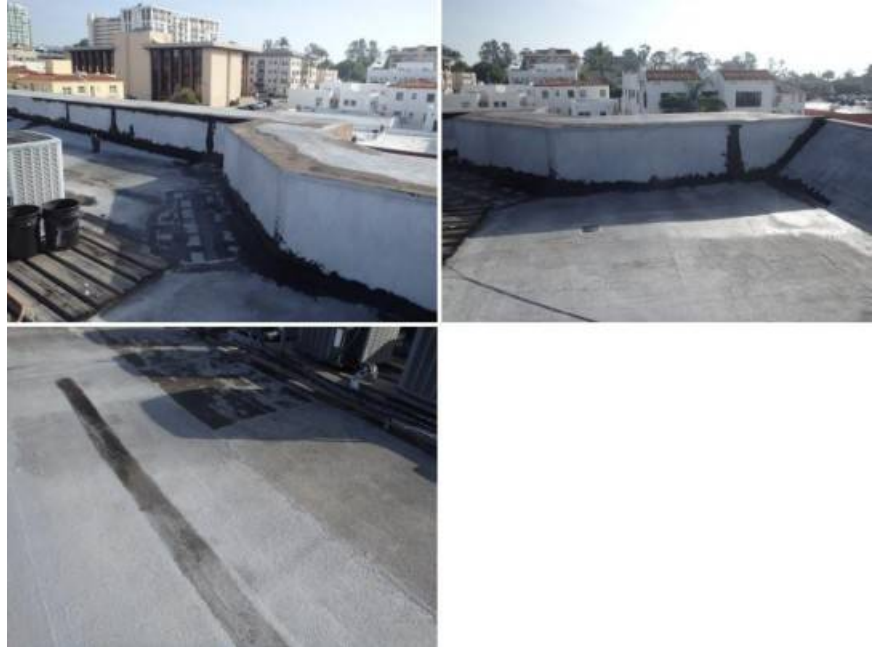
**6.8 Past Repairs:**

**Advisory** - Repairs and/or patching were observed that may indicate the roof has leaked in the past. Recommend asking the seller as to the history of any leaks and subsequent repairs.

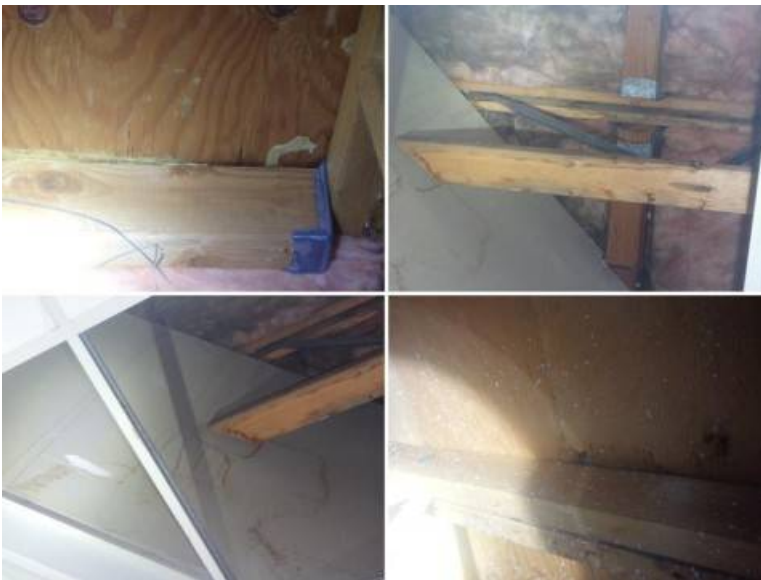
**7.5 Water Stains:**

**Further Evaluation** - Water stains were present on the underside of the roof and deck(s) sheathing or framing as seen inside the attics. Water stains are an indication of water intrusion at some time. This may be an indication of an active leak, an intermittent leak, or the leak could have been repaired. All stains should be investigated by a roofing contractor / decking specialist and repaired as necessary. A

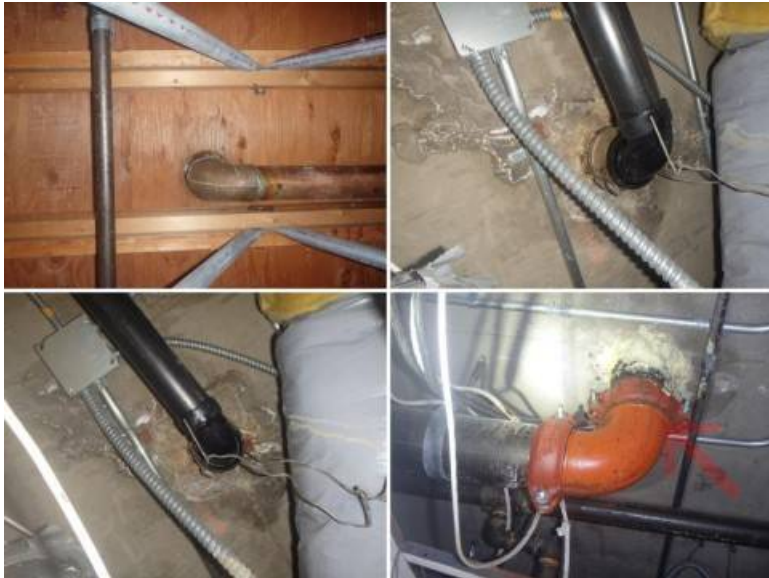
**7.6 Water Stains :**

**Further Evaluation** - Past plumbing leaks and stained framing was viewed at various drain lines. We recommend further evaluation and correction as needed at this time by a licensed plumbing contractor. A licensed pest inspector should evaluate this condition for possible moisture damage. Stains are an indication of a past or present leak, which should also be evaluated further.

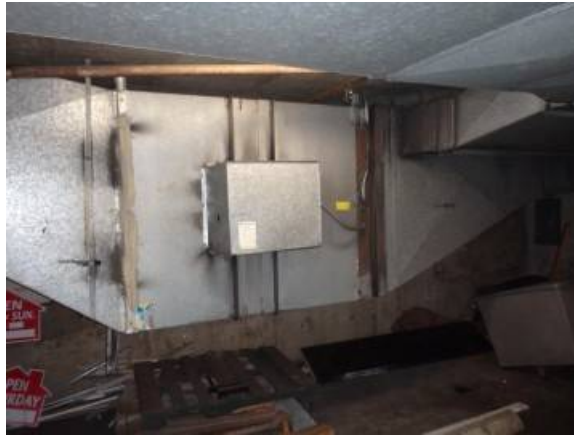
### 8.2 Ventilation Type:

**Further Evaluation** - The air exhaust system was not on during our inspection. Recommend having the seller demonstrate that this system is functional and that the carbon dioxide sensors work to turn on the fan automatically.

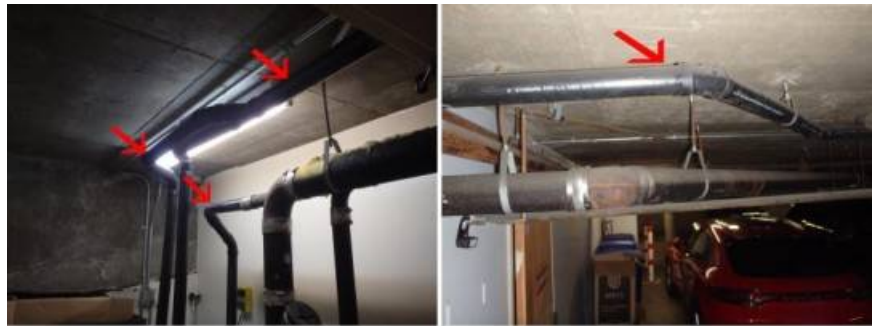
**8.4 Fire Separation:**

**Safety** - Plastic piping is present in the garage. Pipes in a parking garage are required to be metal due to the possibility of fire spreading through the area, melting the pipe allowing fire to spread to other parts of the building.

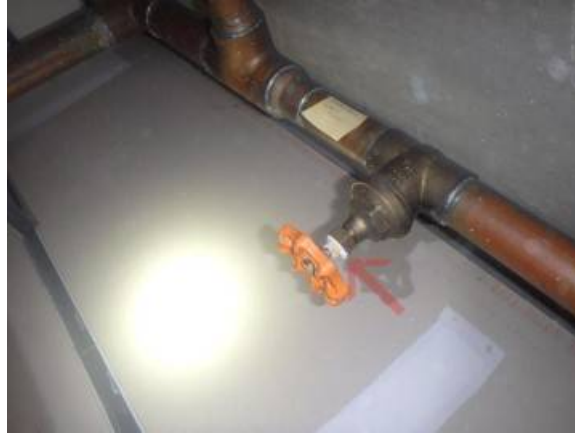
**9.6 Water Supply Pipes:**

**Marginal** - Corrosion was noted on an old gate valve shut-off seen in the basement level suite(s). Be aware that old corroded pipes and fittings are at a higher risk of leaking. Recommend a licensed plumbing contractor for further evaluation.

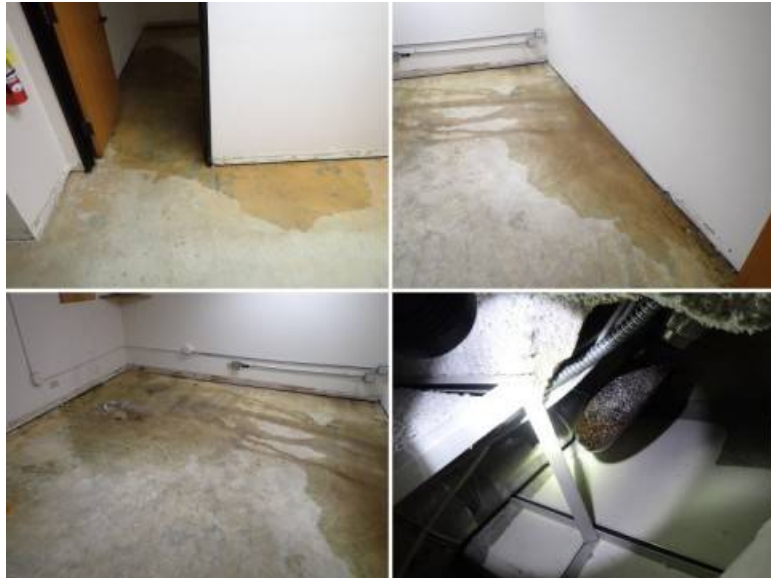
**9.11 Wastewater Pipes :**

**Repair** - An significant active leak, wet subfloor and wet finish materials were noted on the lower office level. The waste plumbing appears to be compromised. Recommend a licensed plumbing contractor for further evaluation and corrections as needed.

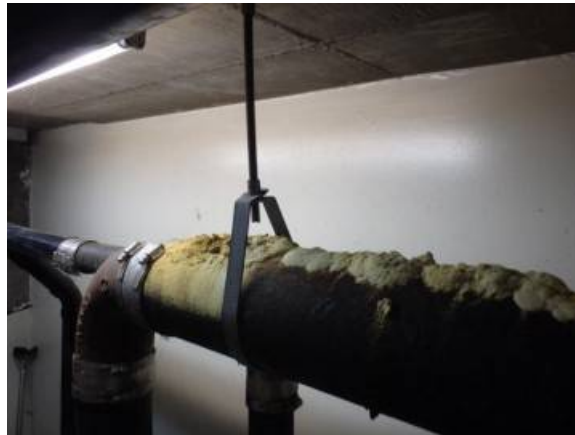
**9.16 Concerns:**

**Further Evaluation** - Excessive corrosion was noted around a pipe as seen in the parking garage near the sewer ejector and various other locations in attic spaces. Stains were noted under sections of corrosion that appears to have dripped in the past. This may be an indication of a past or present leak. . Recommend a licensed plumbing contractor or fire sprinkler specialist for further evaluation and corrections as needed.

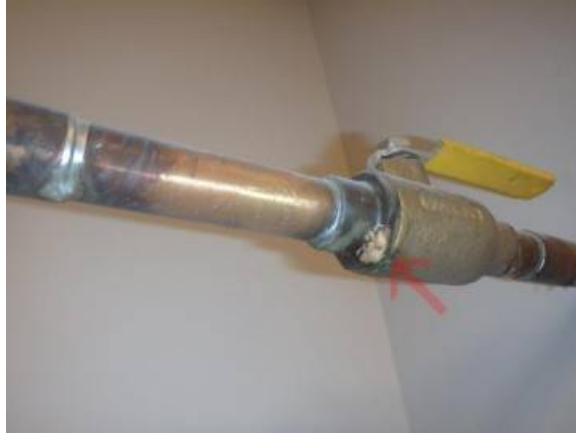
**10.19 Plumbing Connections:**

**Maintenance** - Minor corrosion at shut-off can be evaluated when the water heater is being strapped.

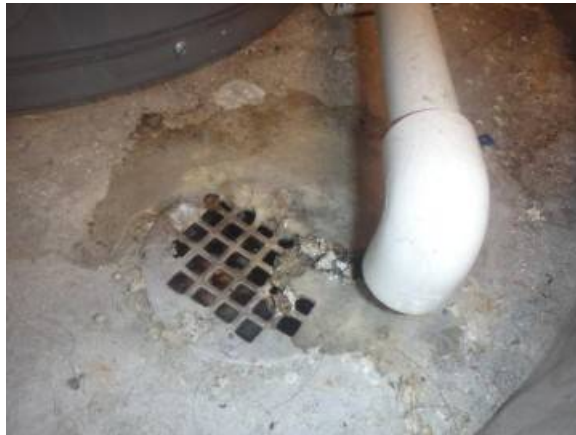
**10.20 Pan & Drain:**

**Maintenance** - We do not know where this pan drain terminates. We recommend having a plumber verify it is draining correctly.

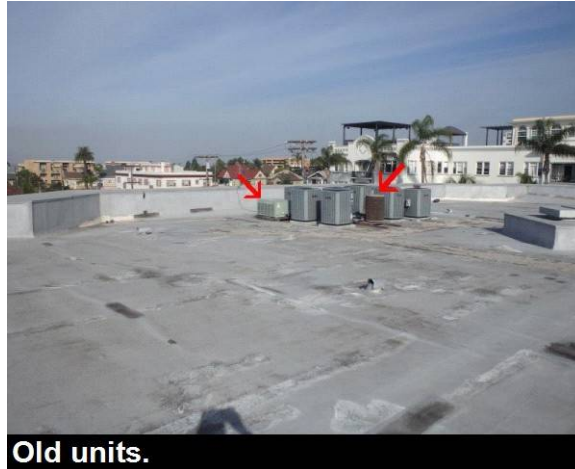
**11.12 Old System:**

- Marginal** - Two of the units are older than its expected service life. Their future performance may not be reliable. We recommend a system evaluation/service by a licensed HVAC contractor and budgeting for replacement of the systems in the near future. It seemed that the interior units on level 1 were older but this could not be determined due to paint on the units/ over the tags. We could not determine how many older units there are on level 1 at the interior. We assume at least 2 are old.
- Advisory** - It seems older units may be running on R-22. Beginning January 1, 2020 R-22 refrigerant will no longer be manufactured or allowed in cooling systems due to environmental issues. This will significantly add to the cost of running older systems. Upgrades recommended.

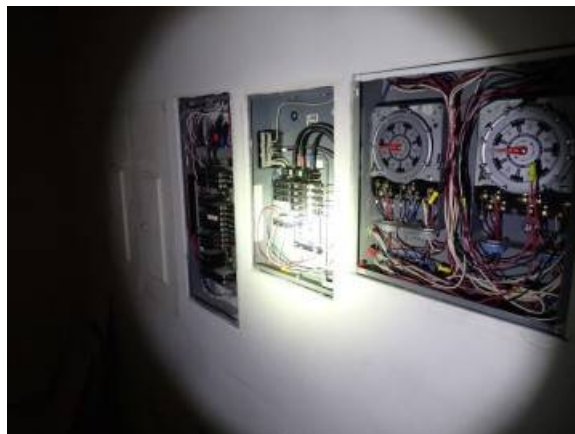
**12.11 Panel Housing:**

**Safety** - The inside "dead front" cover was removed at a sub panels on the lower basement office level. We do not know why these covers were removed so we did not put them back on for safety reasons. The dead front cover is required for weather protection and for basic user safety. Wire connections could be accidentally touched when attempting to turn on/off breakers. **This is a serious safety defect that should be corrected by a licensed electrician.**

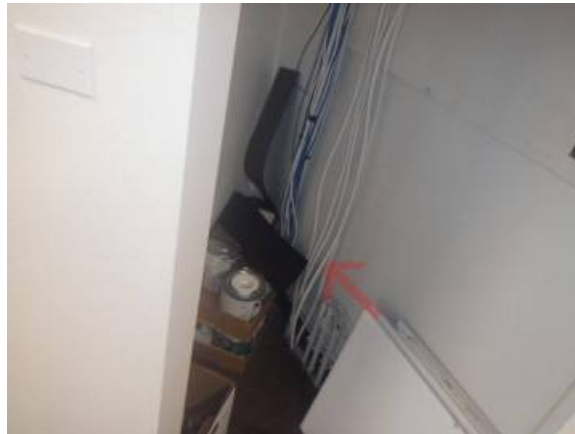
**Maintenance** - Unsecured wiring is present. Loose wiring can be accidentally pulled or disconnected.

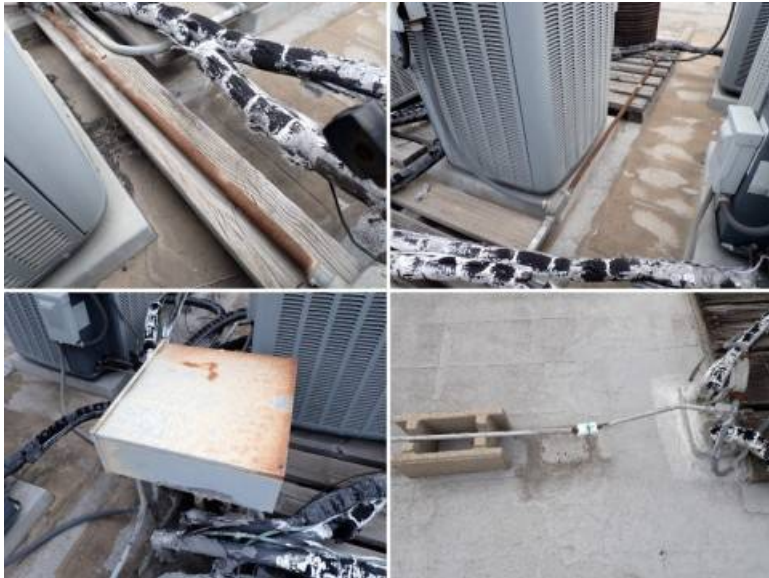
**12.22 Conduit Problems:**

**Marginal**- Metal conduit is old/ corroded. Corrections recommended. We recommend having wiring evaluated at rusty conduit and rusty junction boxes on the roof by a qualified electrician.

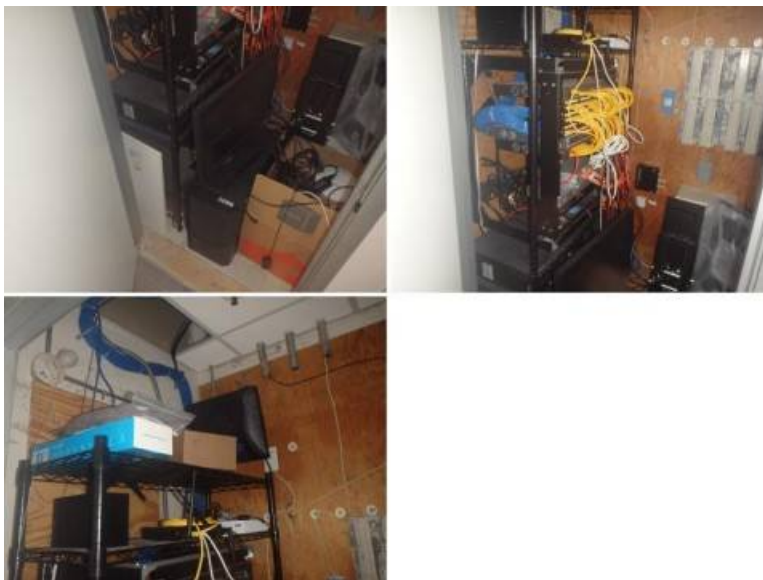
**12.24 Crawlspace:**

**Marginal** - AV/ Vow voltage room on the 3rd Floor is very warm inside from equipment running. Room is congested with electronics. We recommend adding louvered doors to this room for ventilation or adding a 'mini split' cooling system to protect the equipment.

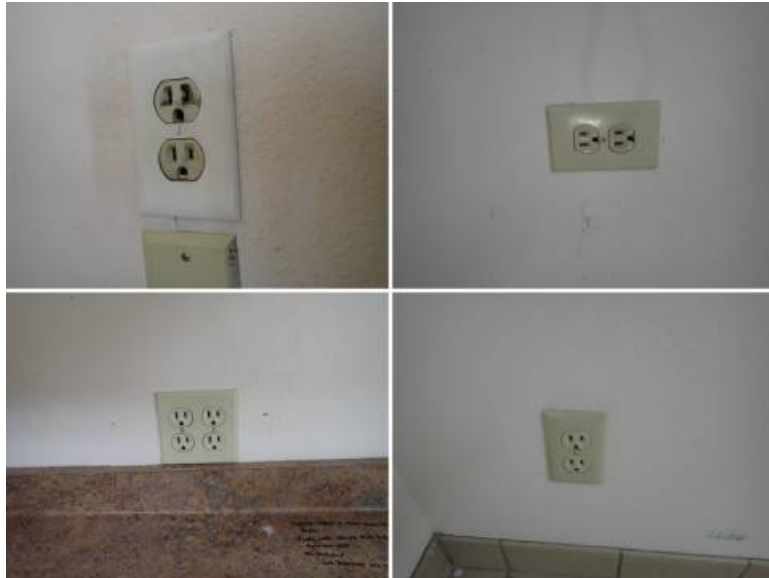
**12.31 Outlets Hazardous:**

**Safety** - A possible scorch mark was observed at an outlet at the lower level office space. This an indication that an arc may have occurred. Regardless if the outlet can be determined as hazardous or not, we recommend replacing it and the coverplate due to the possibility of damaged parts and the increased likelihood of an arc reoccurrence.

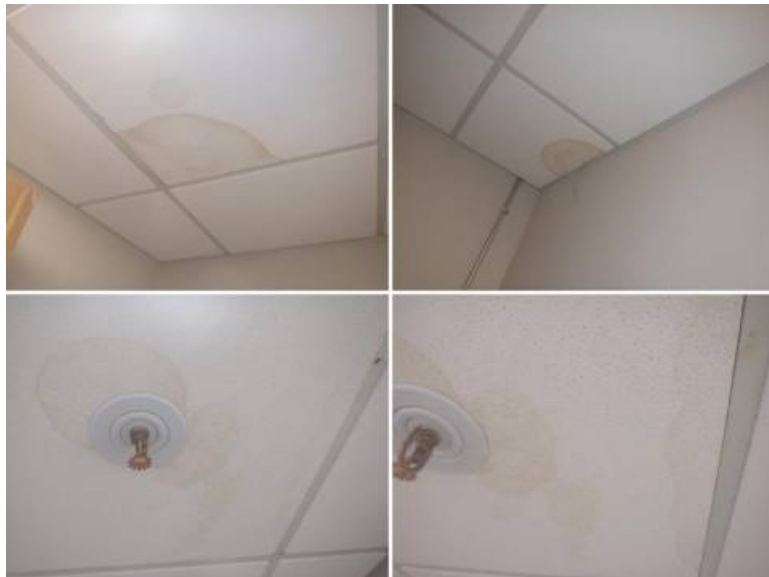
**Further Evaluation** - There were visual signs of past or present plumbing leaks (including sprinkler suppression system) found during the inspection. Leaks or evidence of leaks are described within the section of the report where the leak was found. Dishwasher on the third level was full of stinky water (sitting for long time before inspection) and was leaking underneath the unit after it was opened. Also, be aware that a prolonged leak may cause moisture damage and is conducive for mold growth. You may wish to contact a mold/moisture specialist if there is a concern of latent moisture damage or hidden mold.

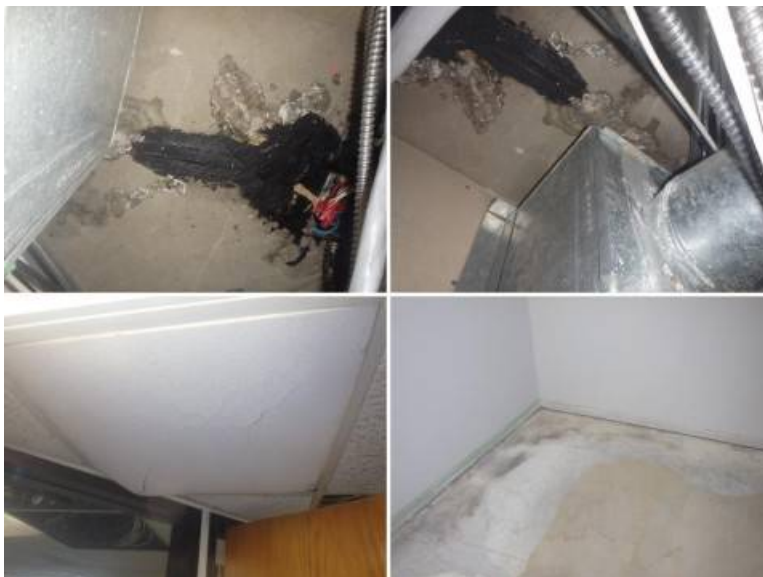
**Further Evaluation** - Water stains and/or water damage was noted at the interior that appear to be associated with subterranean space. There is a concern about moisture intrusion. We recommend correcting the source as well as any damaged materials.

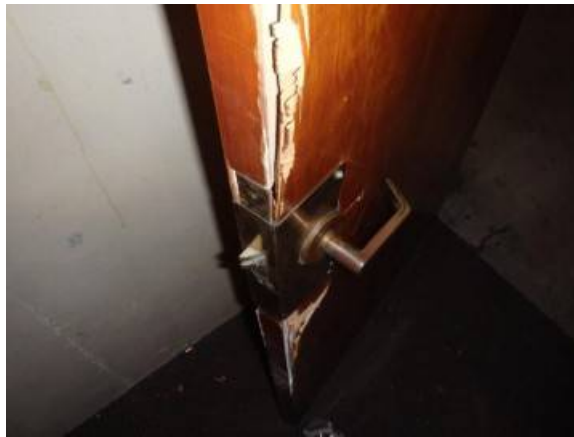
**Safety** - A door from the P1 garage to the stair well is damaged, needs replacement. This damage restricts emergency exiting.

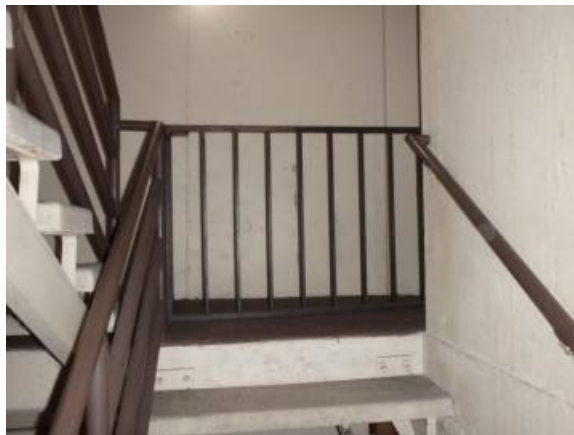
**Safety** - Gates have been installed in the stair well. Nothing that limits exiting is allowed in the emergency stair well.

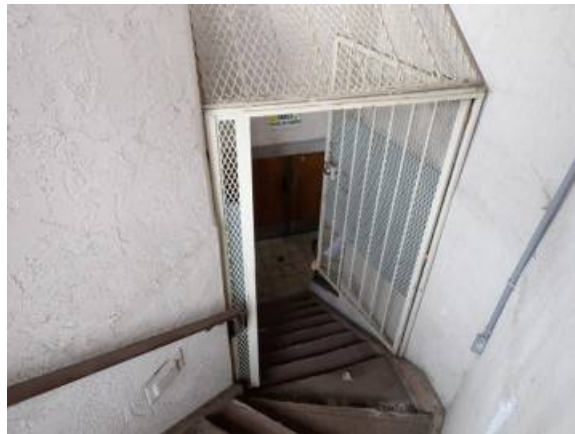
**Safety** - Emergency exit security door(s) open the wrong way impeding emergency exit. Corrections recommended.

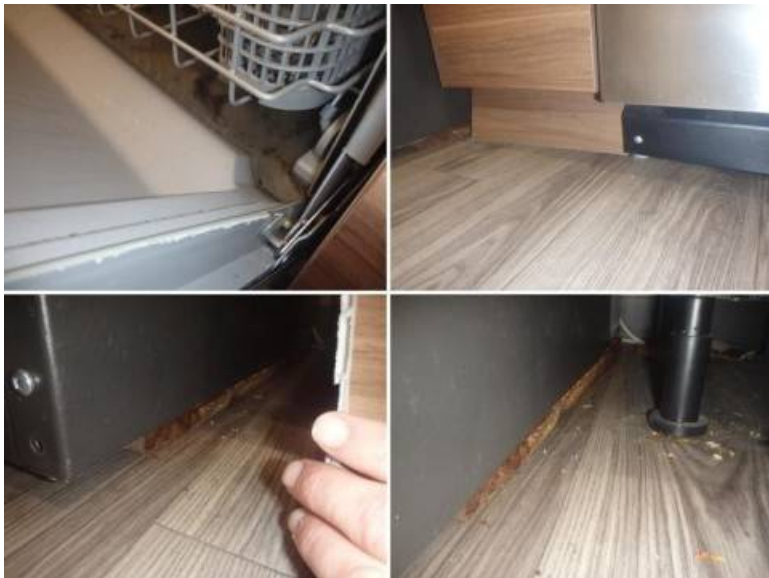
**Repair** - There appears to be a clog in the drain hose or a problem with the air gap installation. We noted moisture damage to the board under the refrigerator before we opened the dishwasher. The dishwasher was not ran. When the dishwasher was opened to check the condition of the inside, it was full of stinky water (had been sitting for a long time). After the door was opened it leaked onto the floor under the dishwasher. We assisted the building manager to clean as much as we could with paper towels from the janitor's closet and continued our inspection with the property manager

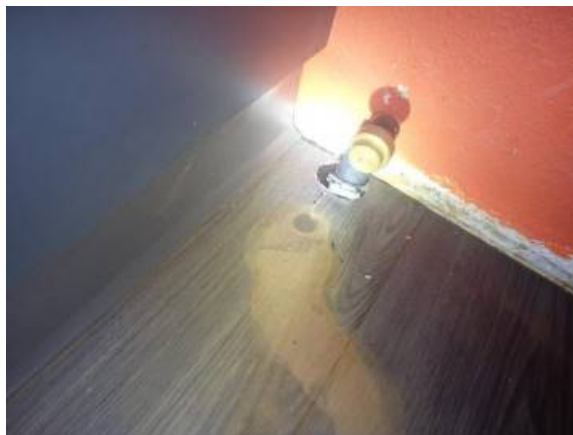
**Marginal** - What appears to be a dishwasher drain was seen on level 2 in suite 200. We did not see where it attaches to the drain under the sink. It is important to attach this drain to an air gap and to the drain system before the trap under the sink to prevent clogging and to prevent sewer gases from entering the dishwasher/ kitchen. If this is a dishwasher drain, corrections are recommended. Additionally some past leaking evidence was noted. We recommend replacing any damaged materials and correcting the source of the leak.

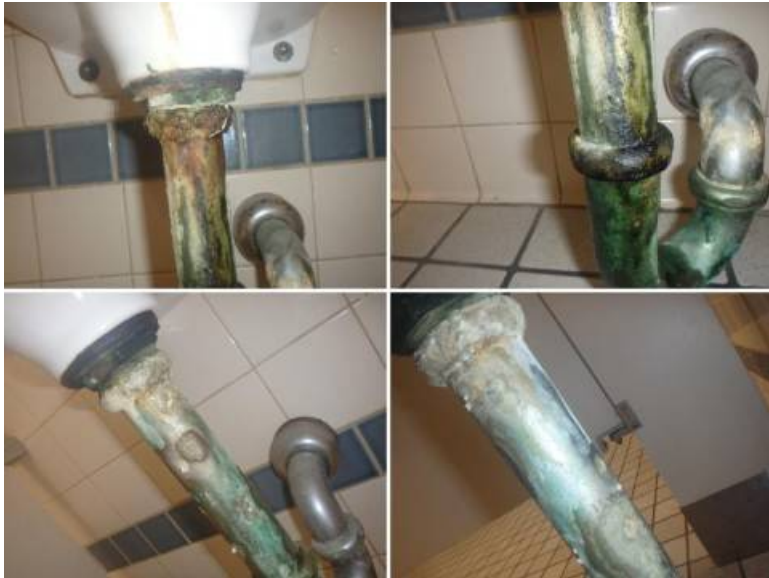
**Repair** - Deterioration/Corrosion noted to the drain line and/or wet trap under the urinal in the 3rd level men's bathroom. A slow leak was found under urinal. The leak should be fixed as well as any damaged materials. Replacement recommended. All Urinals and toilets should be checked for this condition.

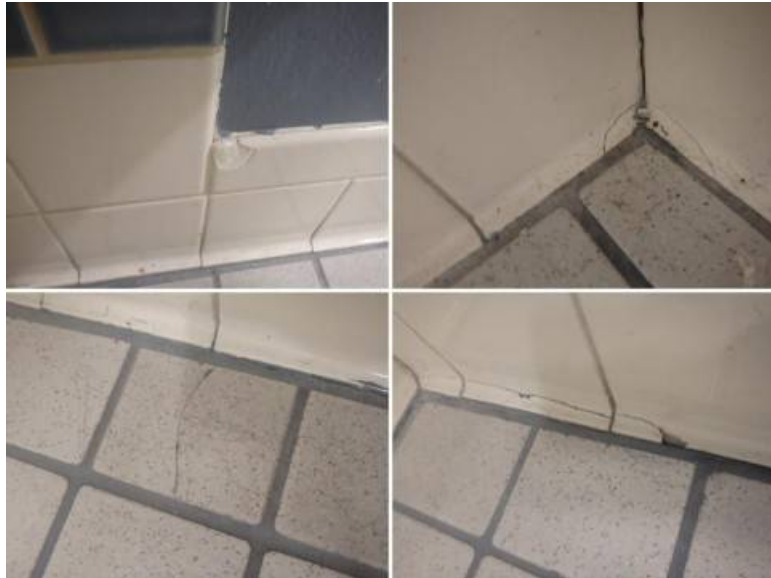
**Maintenance** - Cracked or broken tiles present in many locations. The edge of these tiles can be sharp, these tiles should be checked for this condition.
