**REQUEST FOR SEALED BIDS  
CONSTRUCTION MANAGEMENT SERVICES**

Davidson Inspection Building Inspection Report (File #25-  
1571)

**Re:** 2250 4th Ave., San Diego, Ca 92101  
Inspection Date: 09/12/2025  
File #-25-1571 4th Ave.

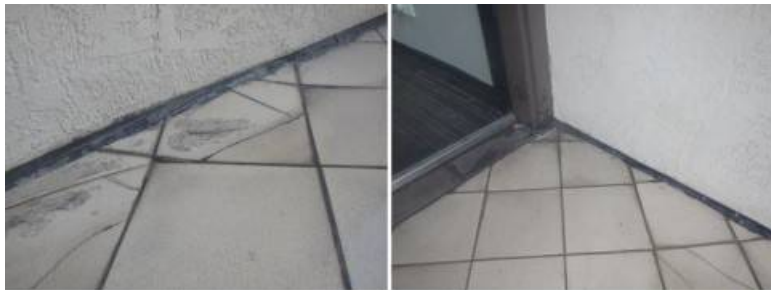
#### 3.3 Soil Gradient Next to Foundation:

**Marginal** - Paved surfaces directed surface runoff toward the foundation in various locations and paving is cracked/ damaged/ settled. Paving abutting the structure should not be pitched so that surface runoff collects against the foundation. Corrective measures recommended.

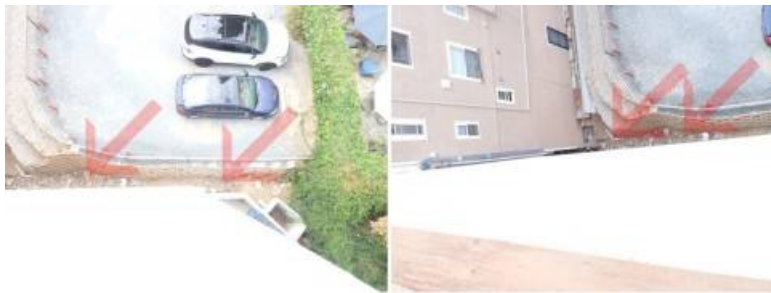
**3.5 Soil Gradient Next to Foundation :**

**Repair** - The soil gradient sloped toward the foundation at the rear. We did not see any means for this low area to drain. The slope should fall away from the foundation to keep surface runoff from collecting at the foundation or a drainage system should carry the water away from the structure. Correcting the soil pitch is needed to improve drainage . Additionally a large pile of rocks and debris is piled up against this side of the structure. Corrective measures recommended.

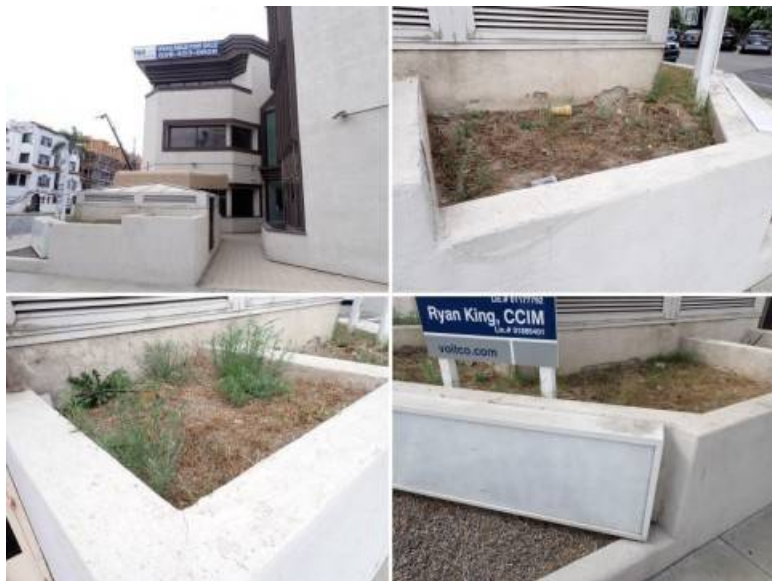
**3.7 Trapped Areas :**

**Further Evaluation** - Surface drainage was blocked / trapped at raised planters. It seems that repairs have been made to the waterproofing system inside the planters. Significant moisture intrusion was present under this area in the basement level suite. We recommend further evaluation by a qualified waterproofing/ drainage specialist to correct this condition. We also recommend a qualified moisture intrusion specialist for further evaluation at this time.

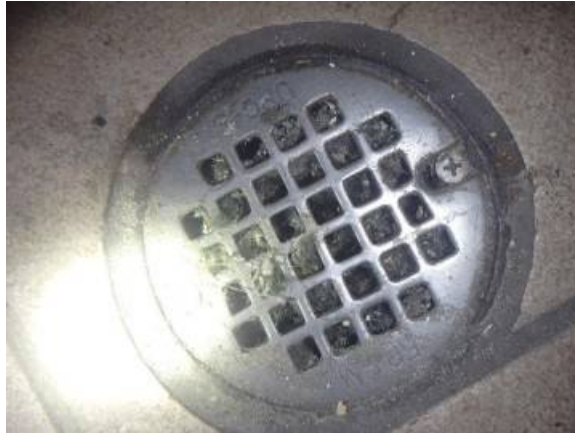
### **3.8 Underground Drains:**

**Maintenance** - Drain inlets were observed to be clogged or partially clogged. Recommend lowering soil grade and/or removing debris from around problem drain inlets. Flushing out drains may also be needed.

**Advisory** - Site grading did not allow for surface runoff to drain off all areas of the building pad. Surface drainage was directed into drain inlets of the subsurface drainage system. Consequently, adequate site drainage was dependent on subsurface drains. It is essential that the subsurface drainage system is functional for adequate site drainage. Recommend verifying that the underground drainage system is functional, and recommend flushing drains annually.

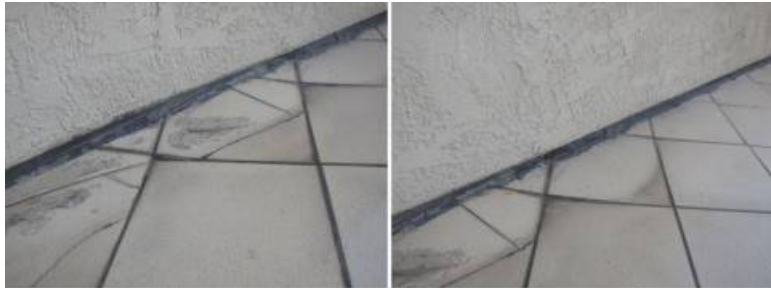
**3.12 Damage:**

**Repair** - Moisture damage and possible moisture intrusion noted to paving. These areas may be leaking to the basement level(s) below. Past repairs have been made in these areas along the walls. Further evaluation and repairs are recommended to halt further damage. See interior section for comments on moisture intrusion.

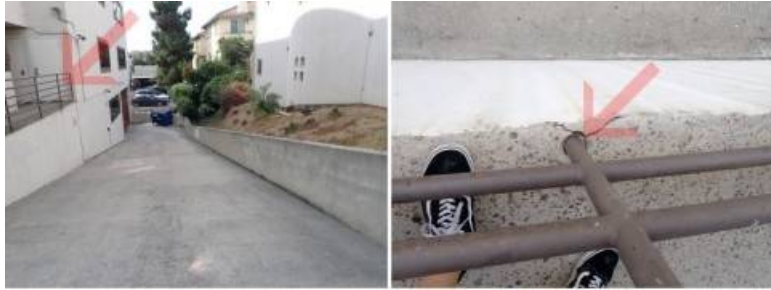
### 3.15 Guardrails:

**Safety** - Railing is loose/weak. Railings should be repaired / replaced for improved safety.

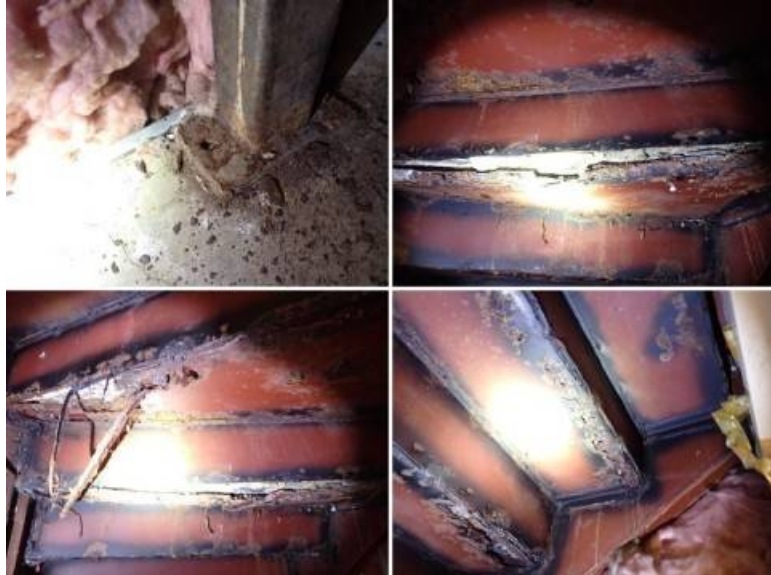
**3.20 Damage :**

**Repair** - Damage/Deterioration was noted to the metal support structure. Storm water has entered this stair well causing damage to the structure. This is the fire escape at the front of the building, so it is very important that this structure be kept in good condition in case of emergency. We recommend further evaluation and correction as needed at this time by a licensed building contractor.

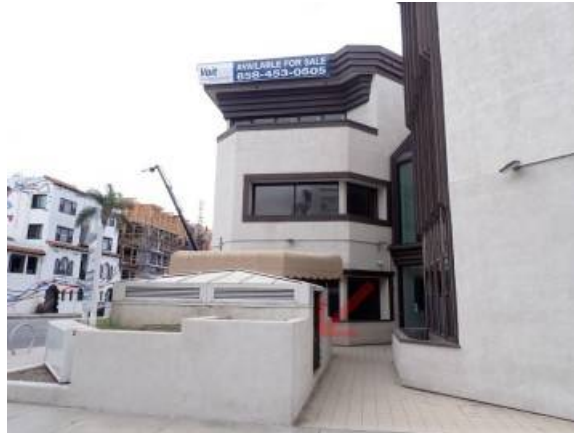
### 3.23 Gate(s):

**Maintenance** - Repair is needed to improve the operation of the gate to the electrical box over the meter rooms and to better keep people out of this area.

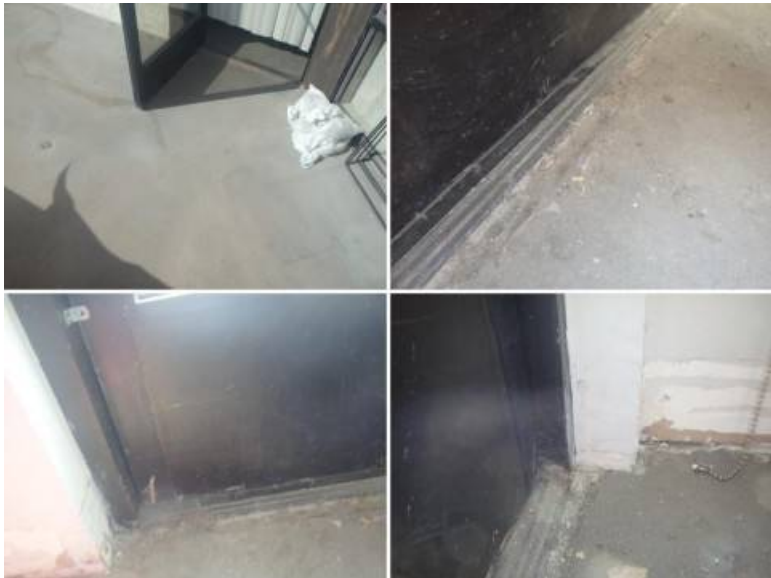
**4.4 Exterior Doors :**

**Further Evaluation** - Water stains and/or water damage was noted at the interior at various doors. There is a concern about moisture intrusion around one or more of the door/window openings. Additionally some deck doors have been caulked at the seams as if a past issue is present with the doors. Sand bags were installed near door openings indicating moisture intrusion issues. We recommend correcting the source as well as any damaged materials.

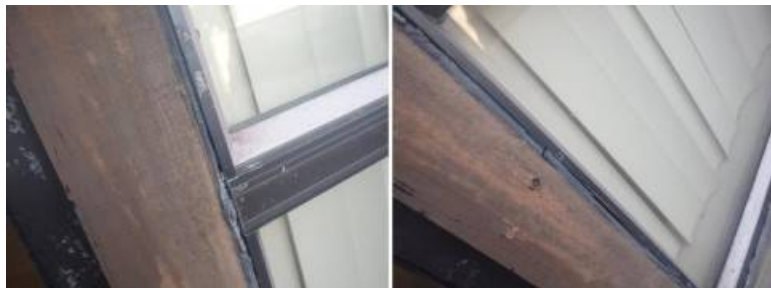
**4.6 Exterior Windows :**

**Maintenance** - Caulking is needed to prevent moisture intrusion.

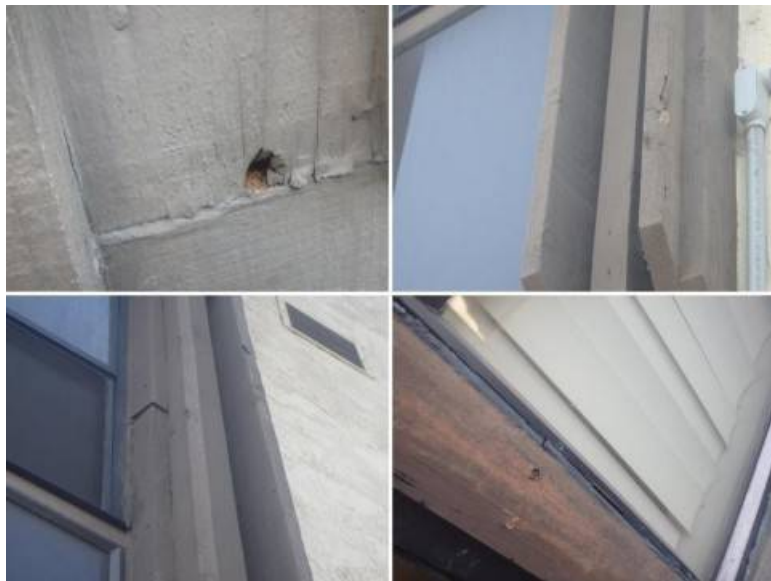
**4.8 Pest Activity:**

**Further Evaluation** - There was evidence of a significant insect infestation. See Pest Inspection Report or have one performed at this time.

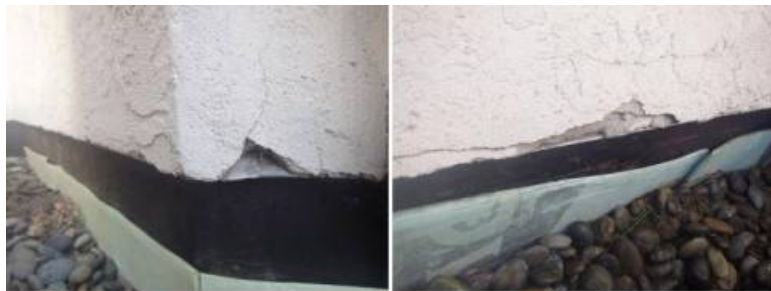
**4.15 Maintenance :**

**Maintenance** - Small areas, typically at corners or bottom edge of the stucco siding, were chipped, loose or missing. Routine repairs recommended. This type of damage is typically caused by excessive moisture. The irrigation system should be checked and adjusted so that the sprinklers are not wetting the building exterior.

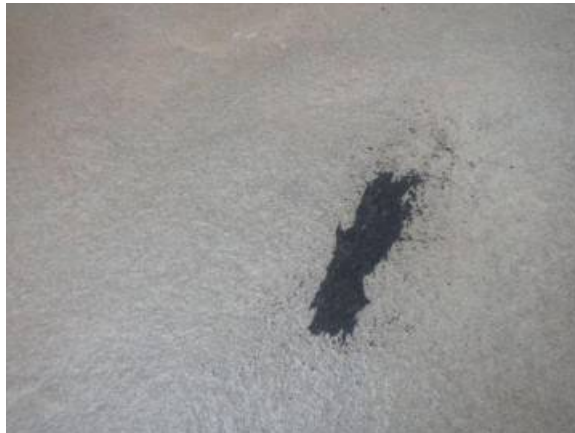
**4.28 Damage:**

**Repair** - There were cracks in the waterproof coating that have been repaired in an unprofessional manner. This condition should be evaluated and corrected by a qualified specialty contractor at this time.

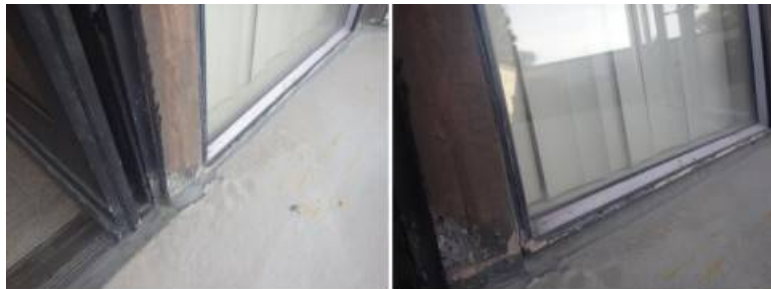
**4.30 Flashing:**

**Marginal** - The deck surface was above the bottom edge of the siding or windows. Siding should terminate above the deck surface to drain properly and to allow for deck flashings to be installed properly. Concealed areas can not be judged to assure a water tight connection. This condition should be evaluated and corrected by a qualified specialty contractor.

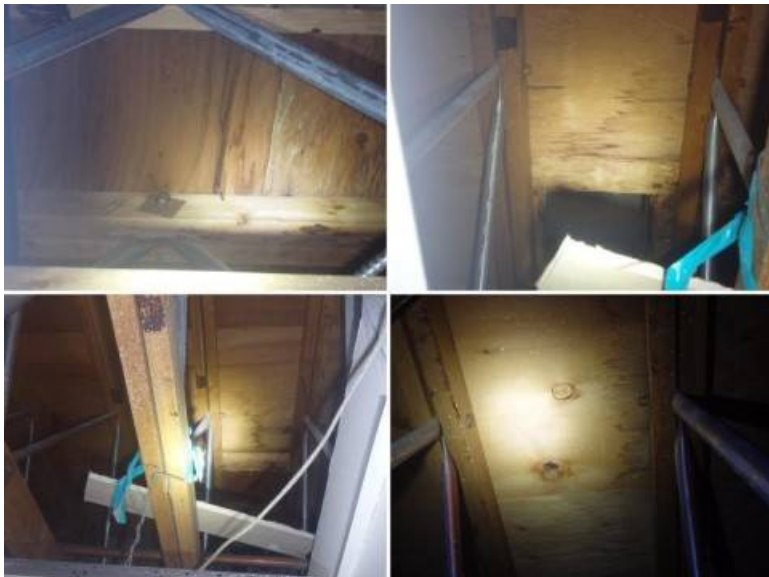
**5.9 Moisture :**

**Further Evaluation** - Excessive water stains noted on framing or sheathing. Moisture intrusion is also present at concrete level(s). Stains are an indication of a past or present leak, which should be investigated further. A licensed pest inspector should evaluate this condition for possible moisture damage.

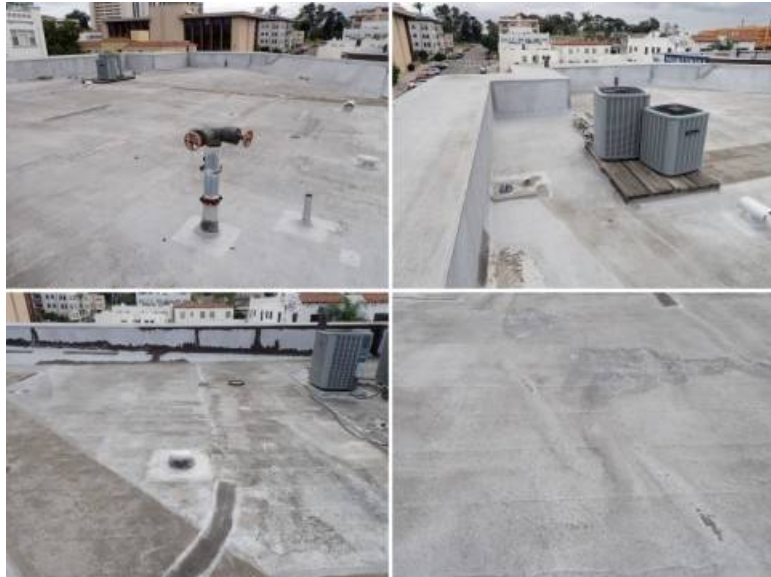
**6.6 Older Roof :**

**Repair** - The roof covering is at end of its useful life. Signs of advanced aging were observed with the roofing material and/or paper underlayment. We recommend replacing the roof covering at this time.

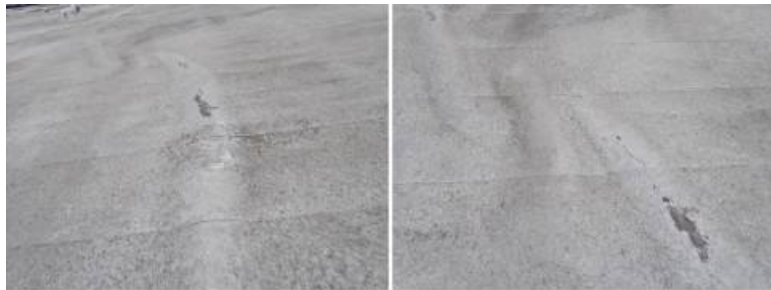
**6.10 Flat Roof Installation:**

**Repair** - The cap sheet was not laying smooth in a few areas. Wrinkled areas were present. This will cause premature wear or damage and may obstruct drainage. Sometimes wrinkles are from moisture getting under the roofing materials. Corrections recommended.

**Marginal** - Poor drainage or 'ponding' was observed at one or more area. Ponding promotes water infiltration and can reduce the service life of the roof.

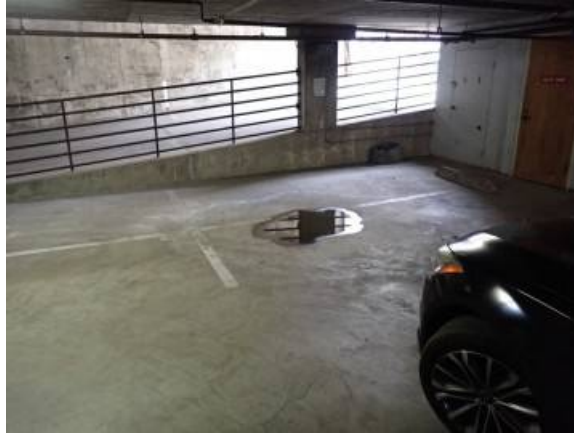
**8.3 Moisture Concerns:**

**Marginal** - The garage is not draining correctly/ areas pond/ or are not sloped correctly. Corrections are recommended for a correctly draining underground parking area/ to prevent flooding.

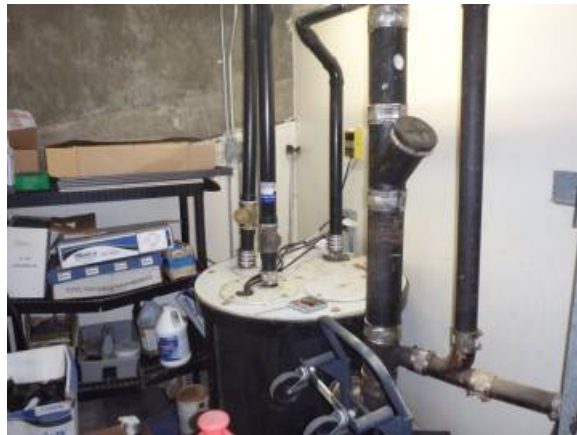
**9.13 Wastewater Ejector:**

**Advisory** - A sewer waste ejector is present. We do not inspect or evaluate sewage ejectors. We only run water until the system turns on to verify that it operates. You should obtain maintenance records from the owner along with any history of repairs. Annual cleaning and inspection of sump pump systems is recommended prior to the rainy season as well as monitoring during rainy periods. Lastly, we recommend further evaluation by a licensed plumbing contractor to determine with certainty that maintenance is current and the pump is in good working order.

**Further Evaluation** - Alarm was not visible/present for the sump pump. It is required to be in place to alert you if the main pump fails so that you can get a plumber to fix it. Installation is required when the sump is the main sewer for the whole floor or

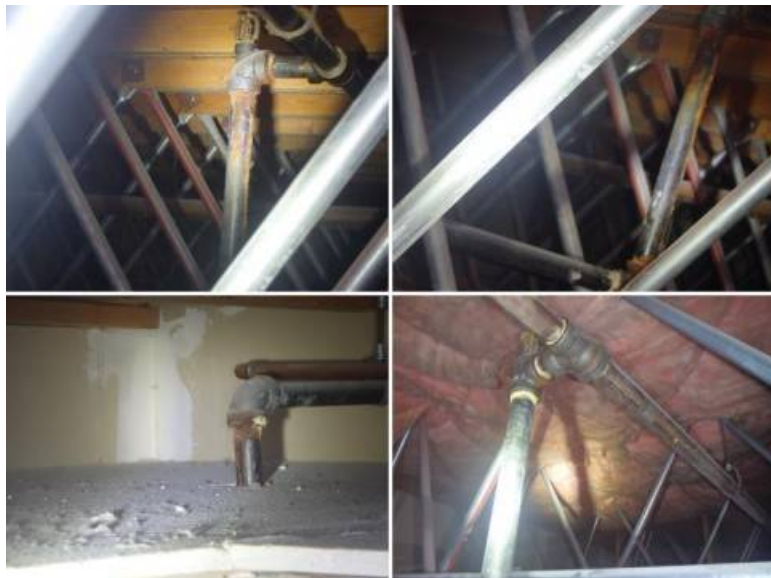
**9.17 Concerns :**

**Further Evaluation** - Excessive corrosion was noted around a pipe as seen in the parking garage near the sewer ejector and various other locations in attic spaces. Stains were noted under sections of corrosion that appears to have dripped in the past. This may be an indication of a past or present leak. . Recommend a licensed plumbing contractor or fire sprinkler specialist for further evaluation and corrections as needed.

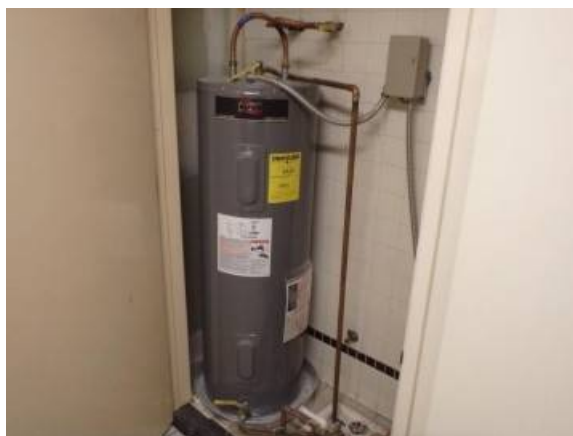
**10.3 Location:**

2nd floor men's room.

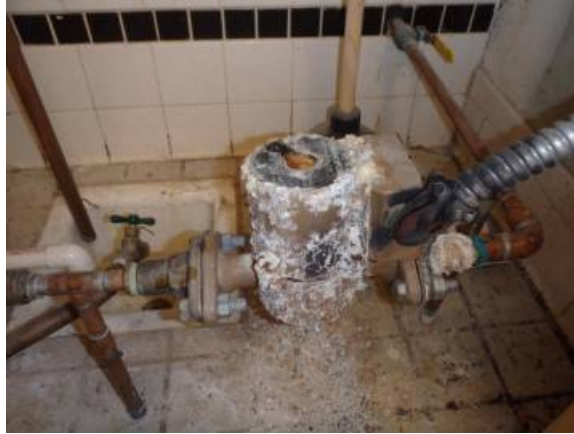
**10.10 Associated Concerns:**

**Repair** - The circulation pump has mineral deposits that indicate that it leaks. We recommend further evaluation and correction as needed at this time by a licensed plumbing contractor.

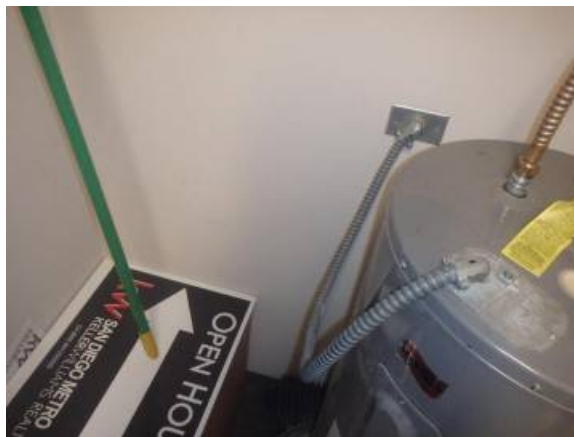
**10.15 Location:**

3rd floor janitor's closet.

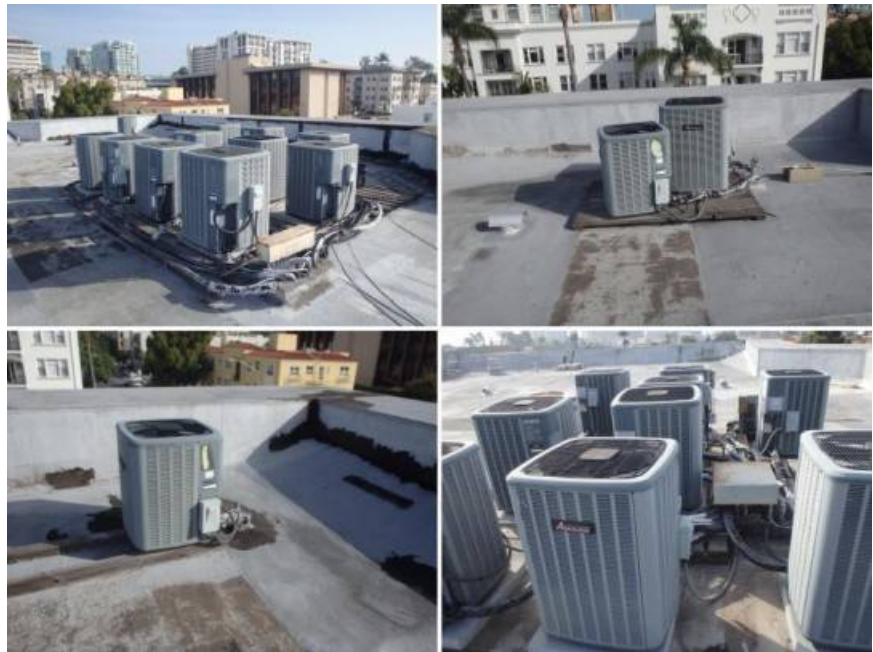
**HEATING UNIT - 1****11.4 Location (Zone):**

Interior ceiling soffit in various locations on each floor. Roof. There are 24 units / zones.

Many units were labeled on level 3 (3A, 3B, 3C, 3E,3F), some on level 2 (2A, 2B,2D, 2E, 2F, one no label) and some on level 1 (1E,1F) . Labels should be added to all areas of the system. Many labels were missing.

- 11.11 Service/Maintenance:** **Maintenance** - A complete service and further evaluation is recommended at this time by a qualified HVAC service contractor.
- Maintenance** - Many units had no labels. We recommend labeling all units similar to the way they were labeled on level 3.

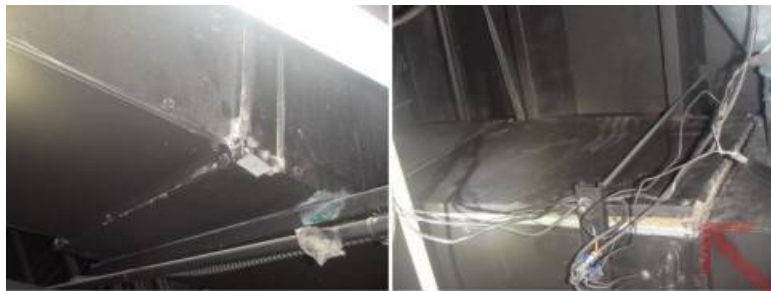
**11.13 Housing:**

- Marginal** -Screws are loose and housing(s) are disconnected at a few units on level 1.

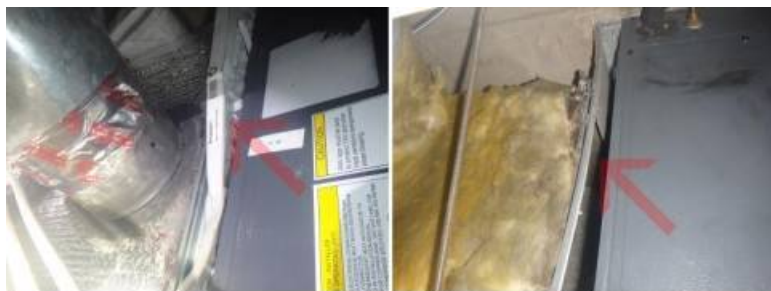
**11.14 Filter(s):**

- Maintenance** - Missing filter(s) noted in various locations.
- Maintenance** - Poorly fitted filter(s) were noted. Suggest replacing the filter(s).

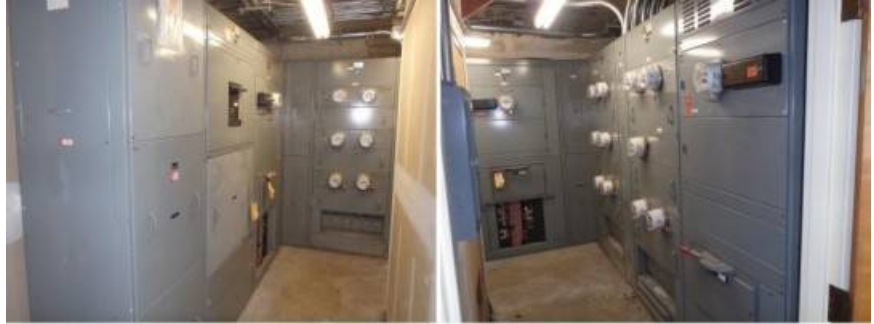
**12.6 Condition:**

Functional.

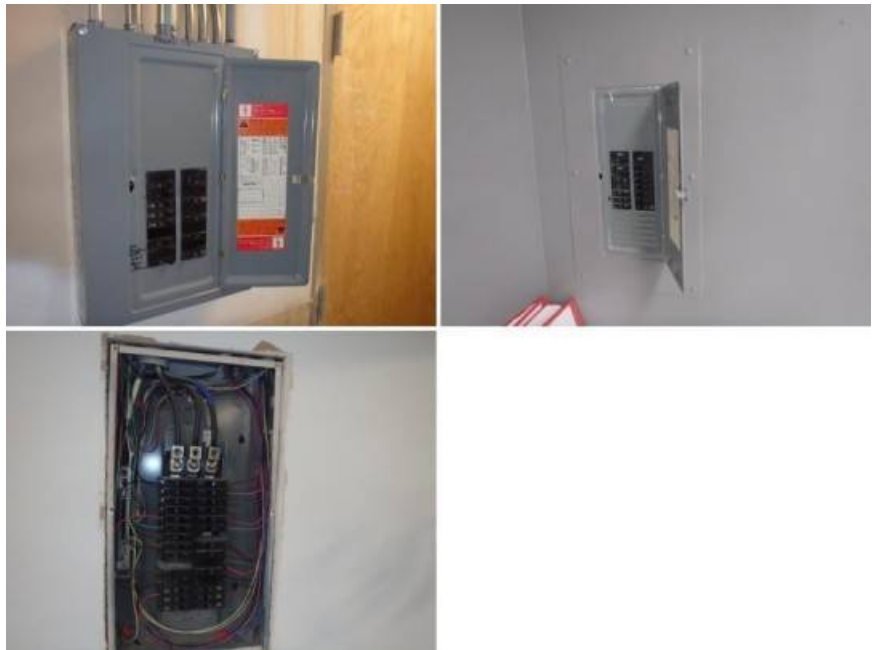
**12.7 Location:**

Various locations on each level.

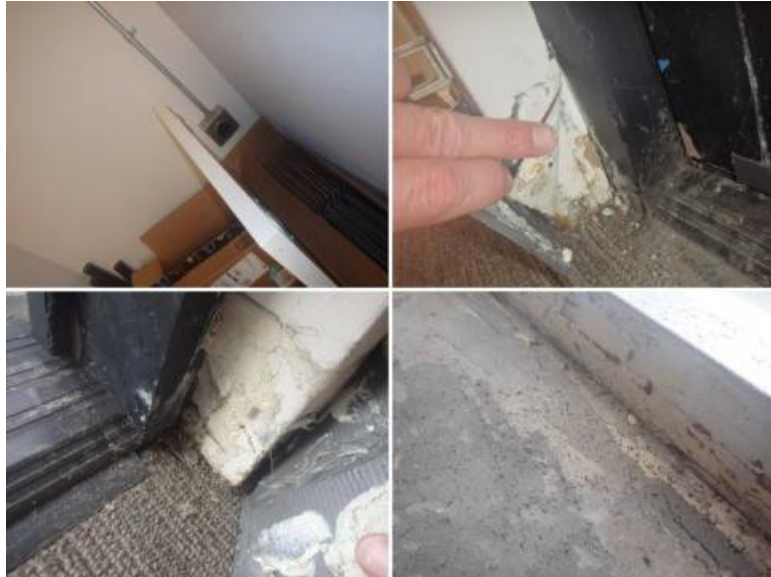
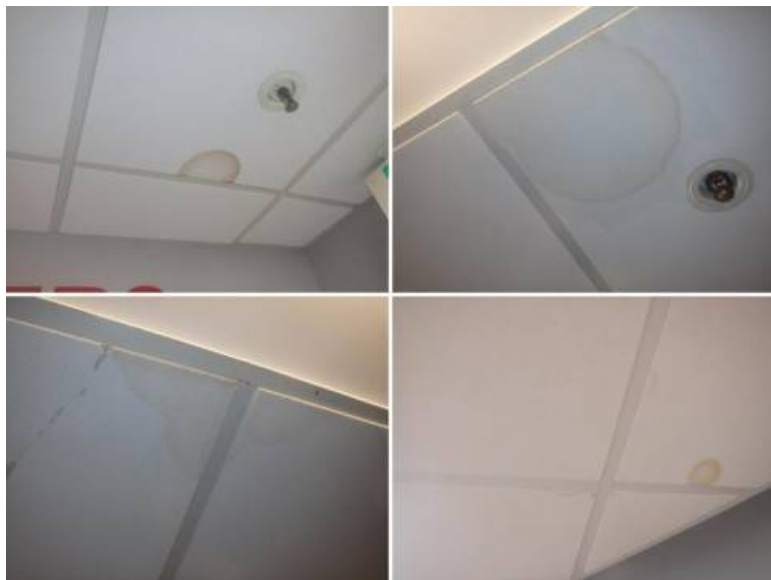
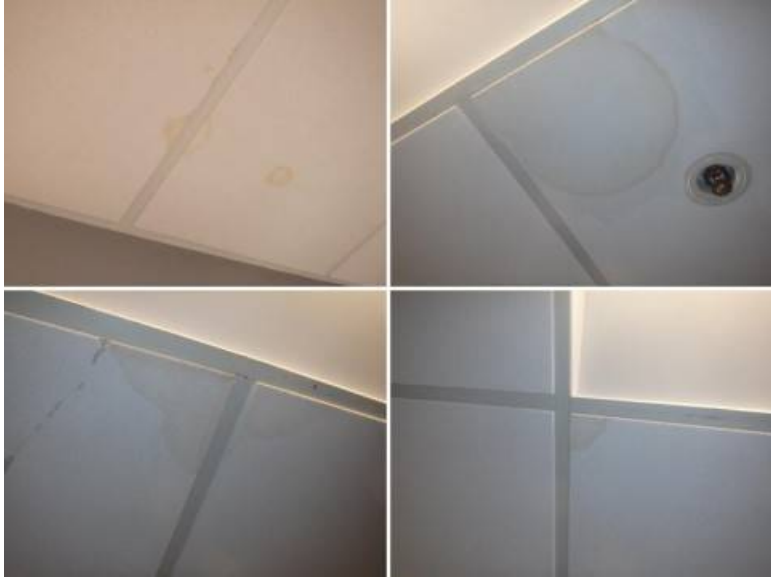
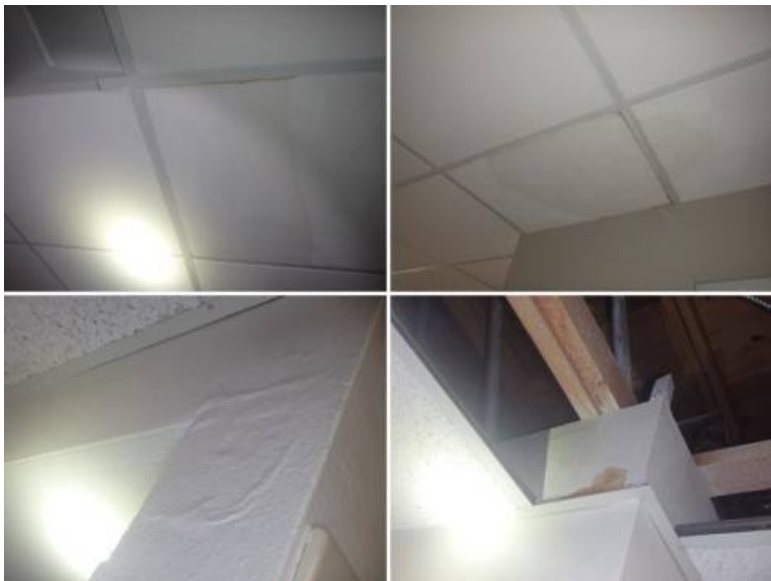
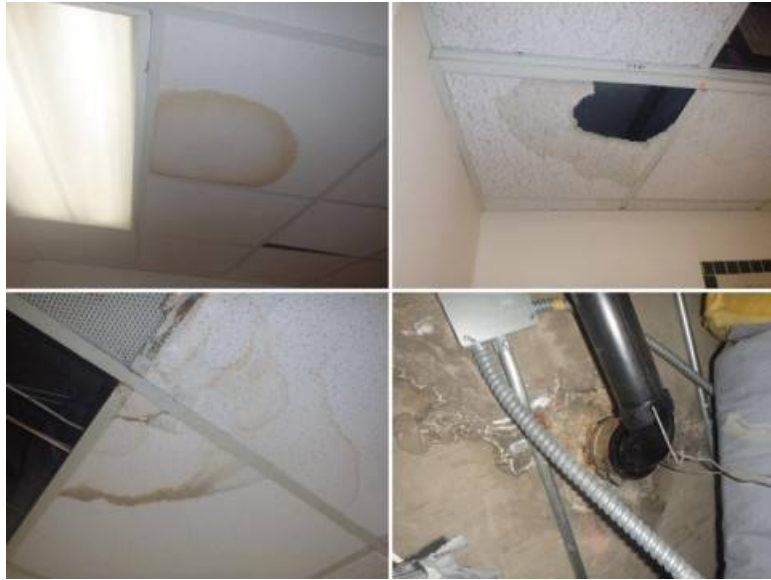
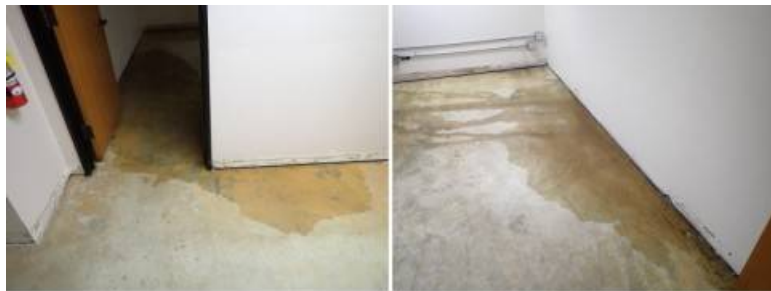
**Further Evaluation** - Water stains and/or water damage was noted at the interior around window opening(s). There is a concern about moisture intrusion. The window may not have proper weather protection or flashing. We recommend correcting the source as well as any damaged materials.

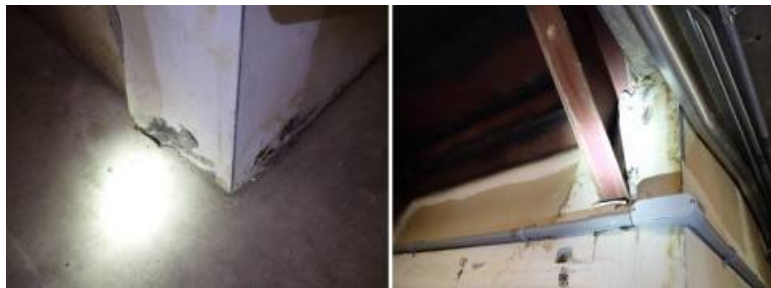
**13.8 Possible Mold:**

**Further Evaluation** - Mold / Mildew like substance was observed at the interior of the electric room closet and at floors of the P3 level (basement suites). Identifying mold is beyond our scope and expertise. We recommend that this condition be evaluated by a qualified specialist.

**Further Evaluation** - A musty odor was present at the P3 level (basement suites). . While we do not know the cause of this odor, there is a concern with moisture. Recommend asking the seller regarding the history of any water or moisture problems. Also, you may wish to contact a mold/moisture specialist for further evaluation.

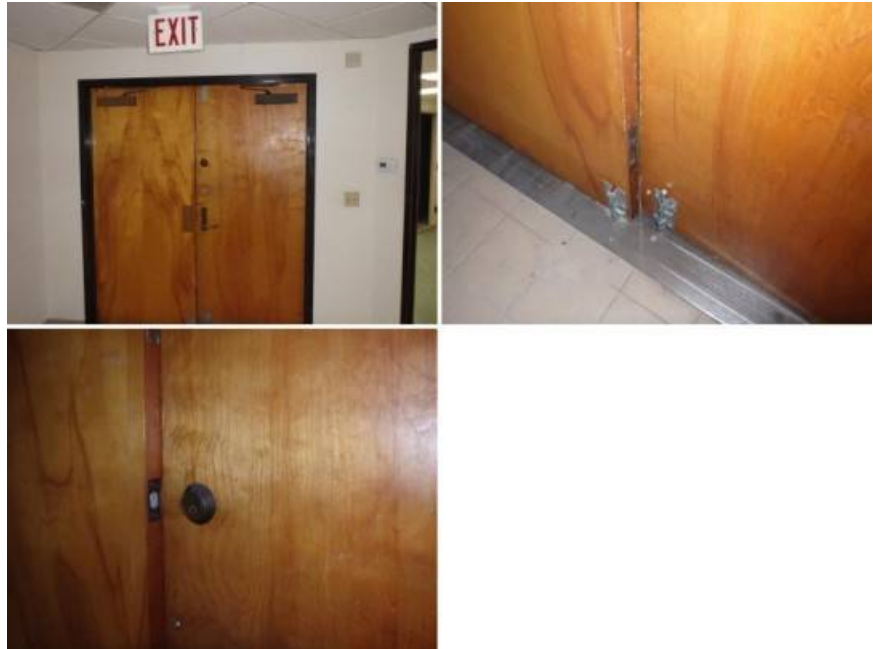
**Safety** - Gates have been installed in the stair well. Nothing that limits exiting is allowed in the emergency stair well.

**Safety** - The emergency stairs have been used to store materials. This is not allowed, these materials need to be removed.

**Safety** - Emergency exits doors have slide bolts and deadbolts installed on floor p3. Locks that restrict exiting are not allowed in exit halls.

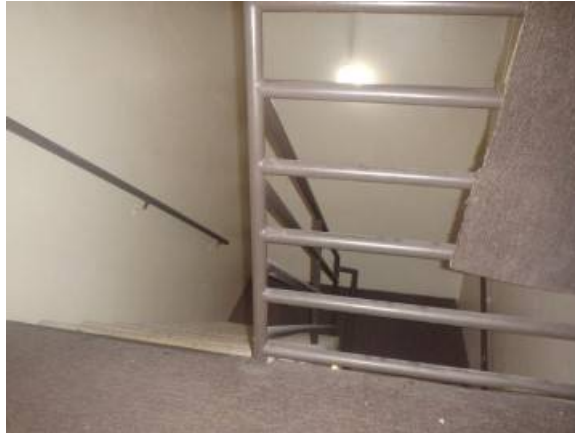
**13.23 Guardrails:**

**Safety** - Wide openings in railings were present. This should be considered an injury hazard. The current requirement is for openings to be no wider than 4".

**Safety** - The railings are horizontal creating a climbable condition. While this allowed by current standards, this could be a hazard for small children. You may wish to consider taking precautions such as covering with plexiglass to prevent climbing.

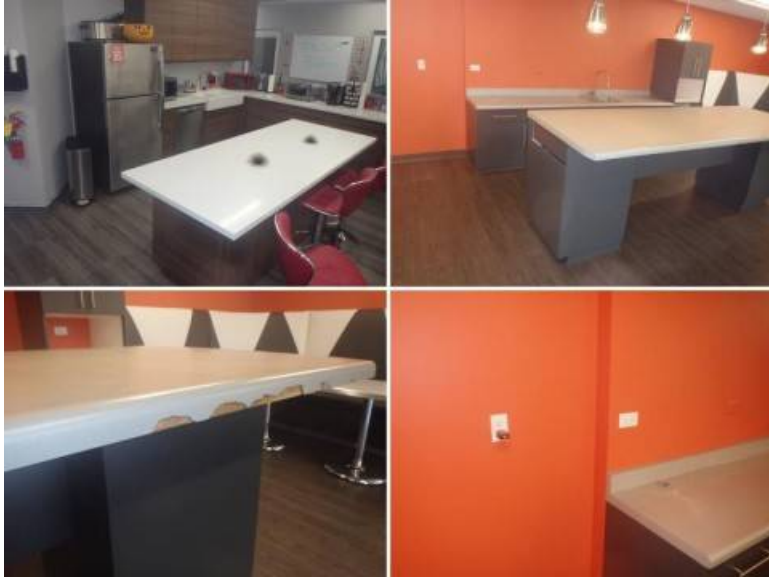
**14.1 Finish Surfaces:**

Kitchen areas present on the 3rd floor, 2nd floor and 1st floor.  
Countertop and cabinet finish surfaces had average wear.

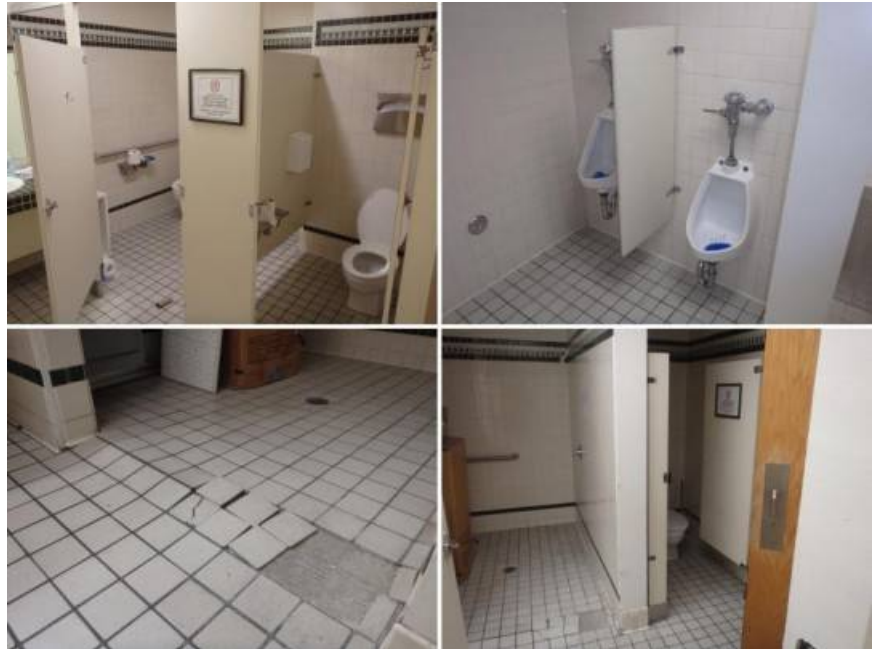
**16.2 Finish Surfaces:**

Countertop and cabinet finish surfaces had heavy wear in bathrooms on level 1 and P3 (basement suite).

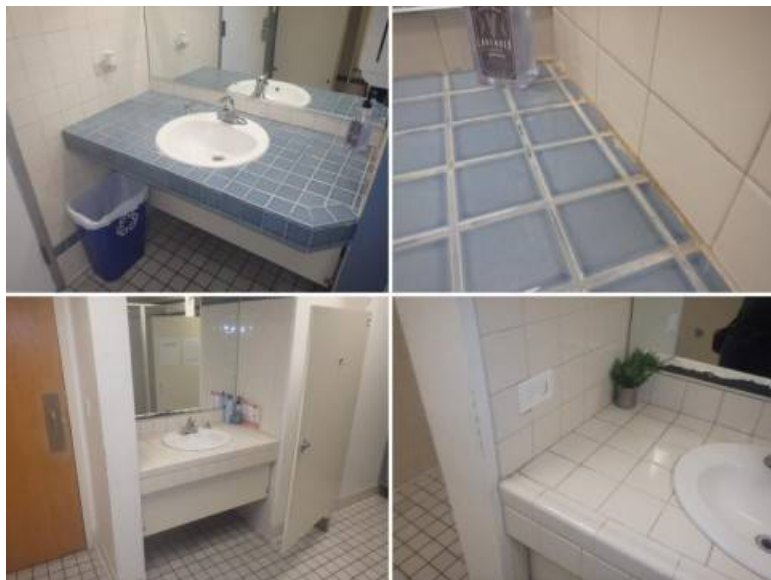
**16.3**

Countertop and cabinet finish surfaces had average wear in various other bathrooms.

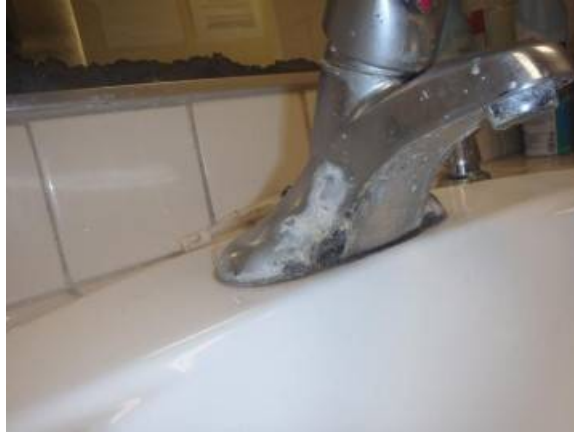
**16.6 Sink Plumbing Fixture:**

**Repair** - Old/ Deteriorated plumbing fixtures noted in a few bathrooms. Recommend replacement.

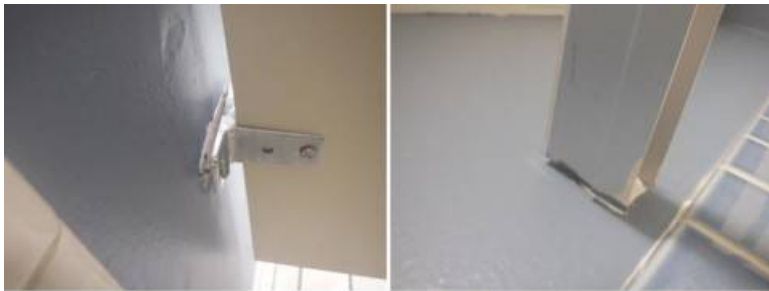
**16.9 Miscellaneous:**

**Maintenance** - Bathroom dividers were loose or missing in various locations.
