## **KITCHENS FOR GOOD**

### **FEASIBILITY STUDY**

**CEI PROJECT NO. 261200**

**August 07, 2026**

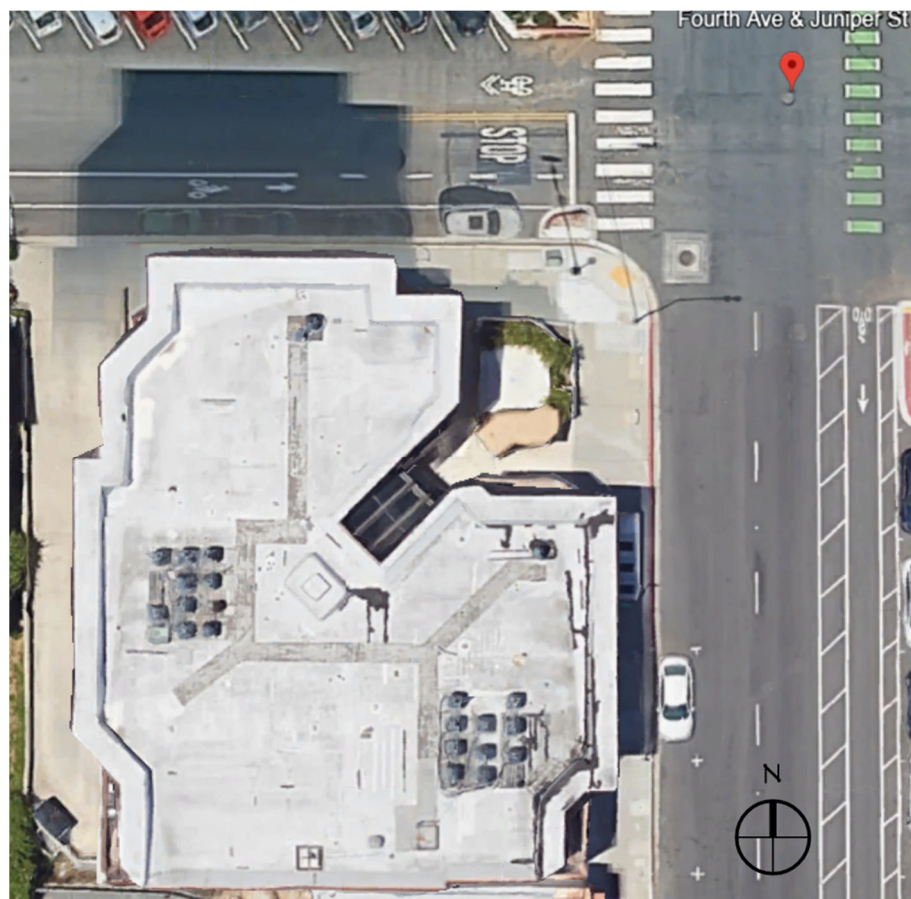
Figure 1: Project Site

The existing structure is a three-story wood-framed building over three levels of concrete framed subterranean basement and parking levels. The site generally slopes from the NE to the SW with the first floor aligned with street level at the corner of 4<sup>th</sup> Avenue and Juniper Street. A ramp located along the West side of the structure connects the Juniper Street level down to the Level 1 parking entrance at the SW corner of the site. An overview of the project site and surrounding area is shown in Figure 1.

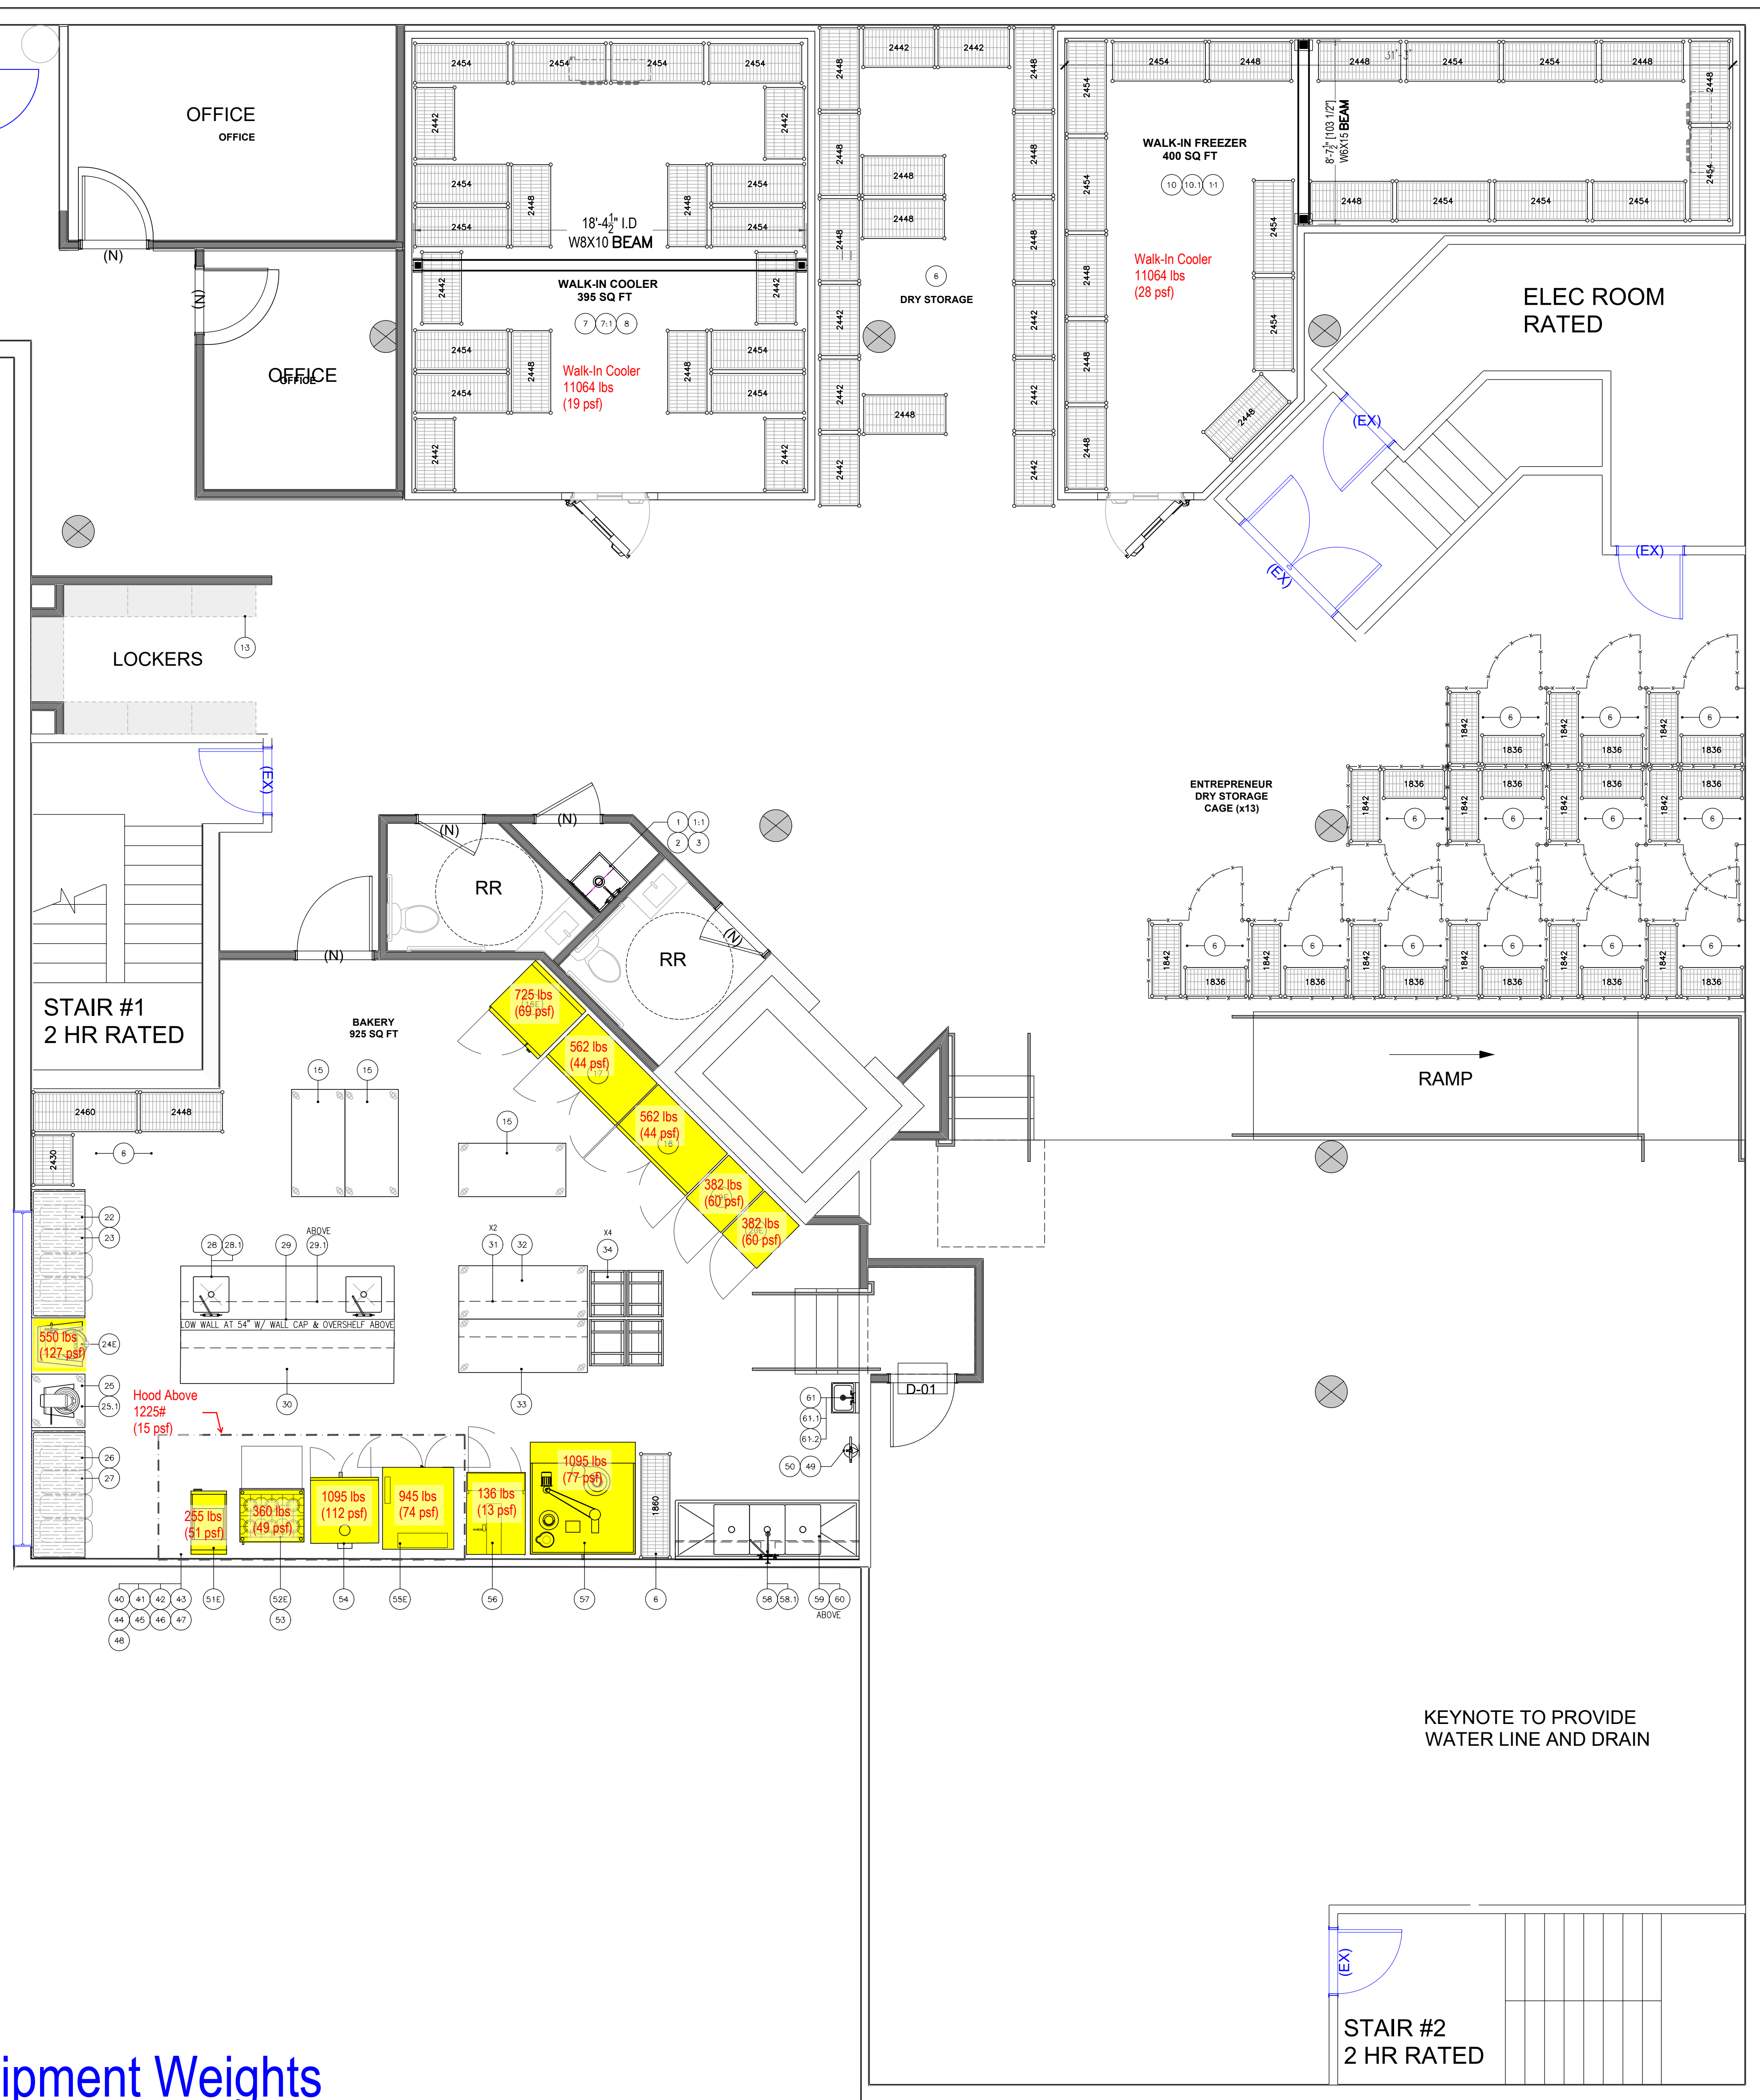
K101

06/09/2026 - Kitchen Equipment Weights

FOODSERVICE EQUIPMENT FLOOR PLAN - BASEMENT

1/4" = 1'-0"

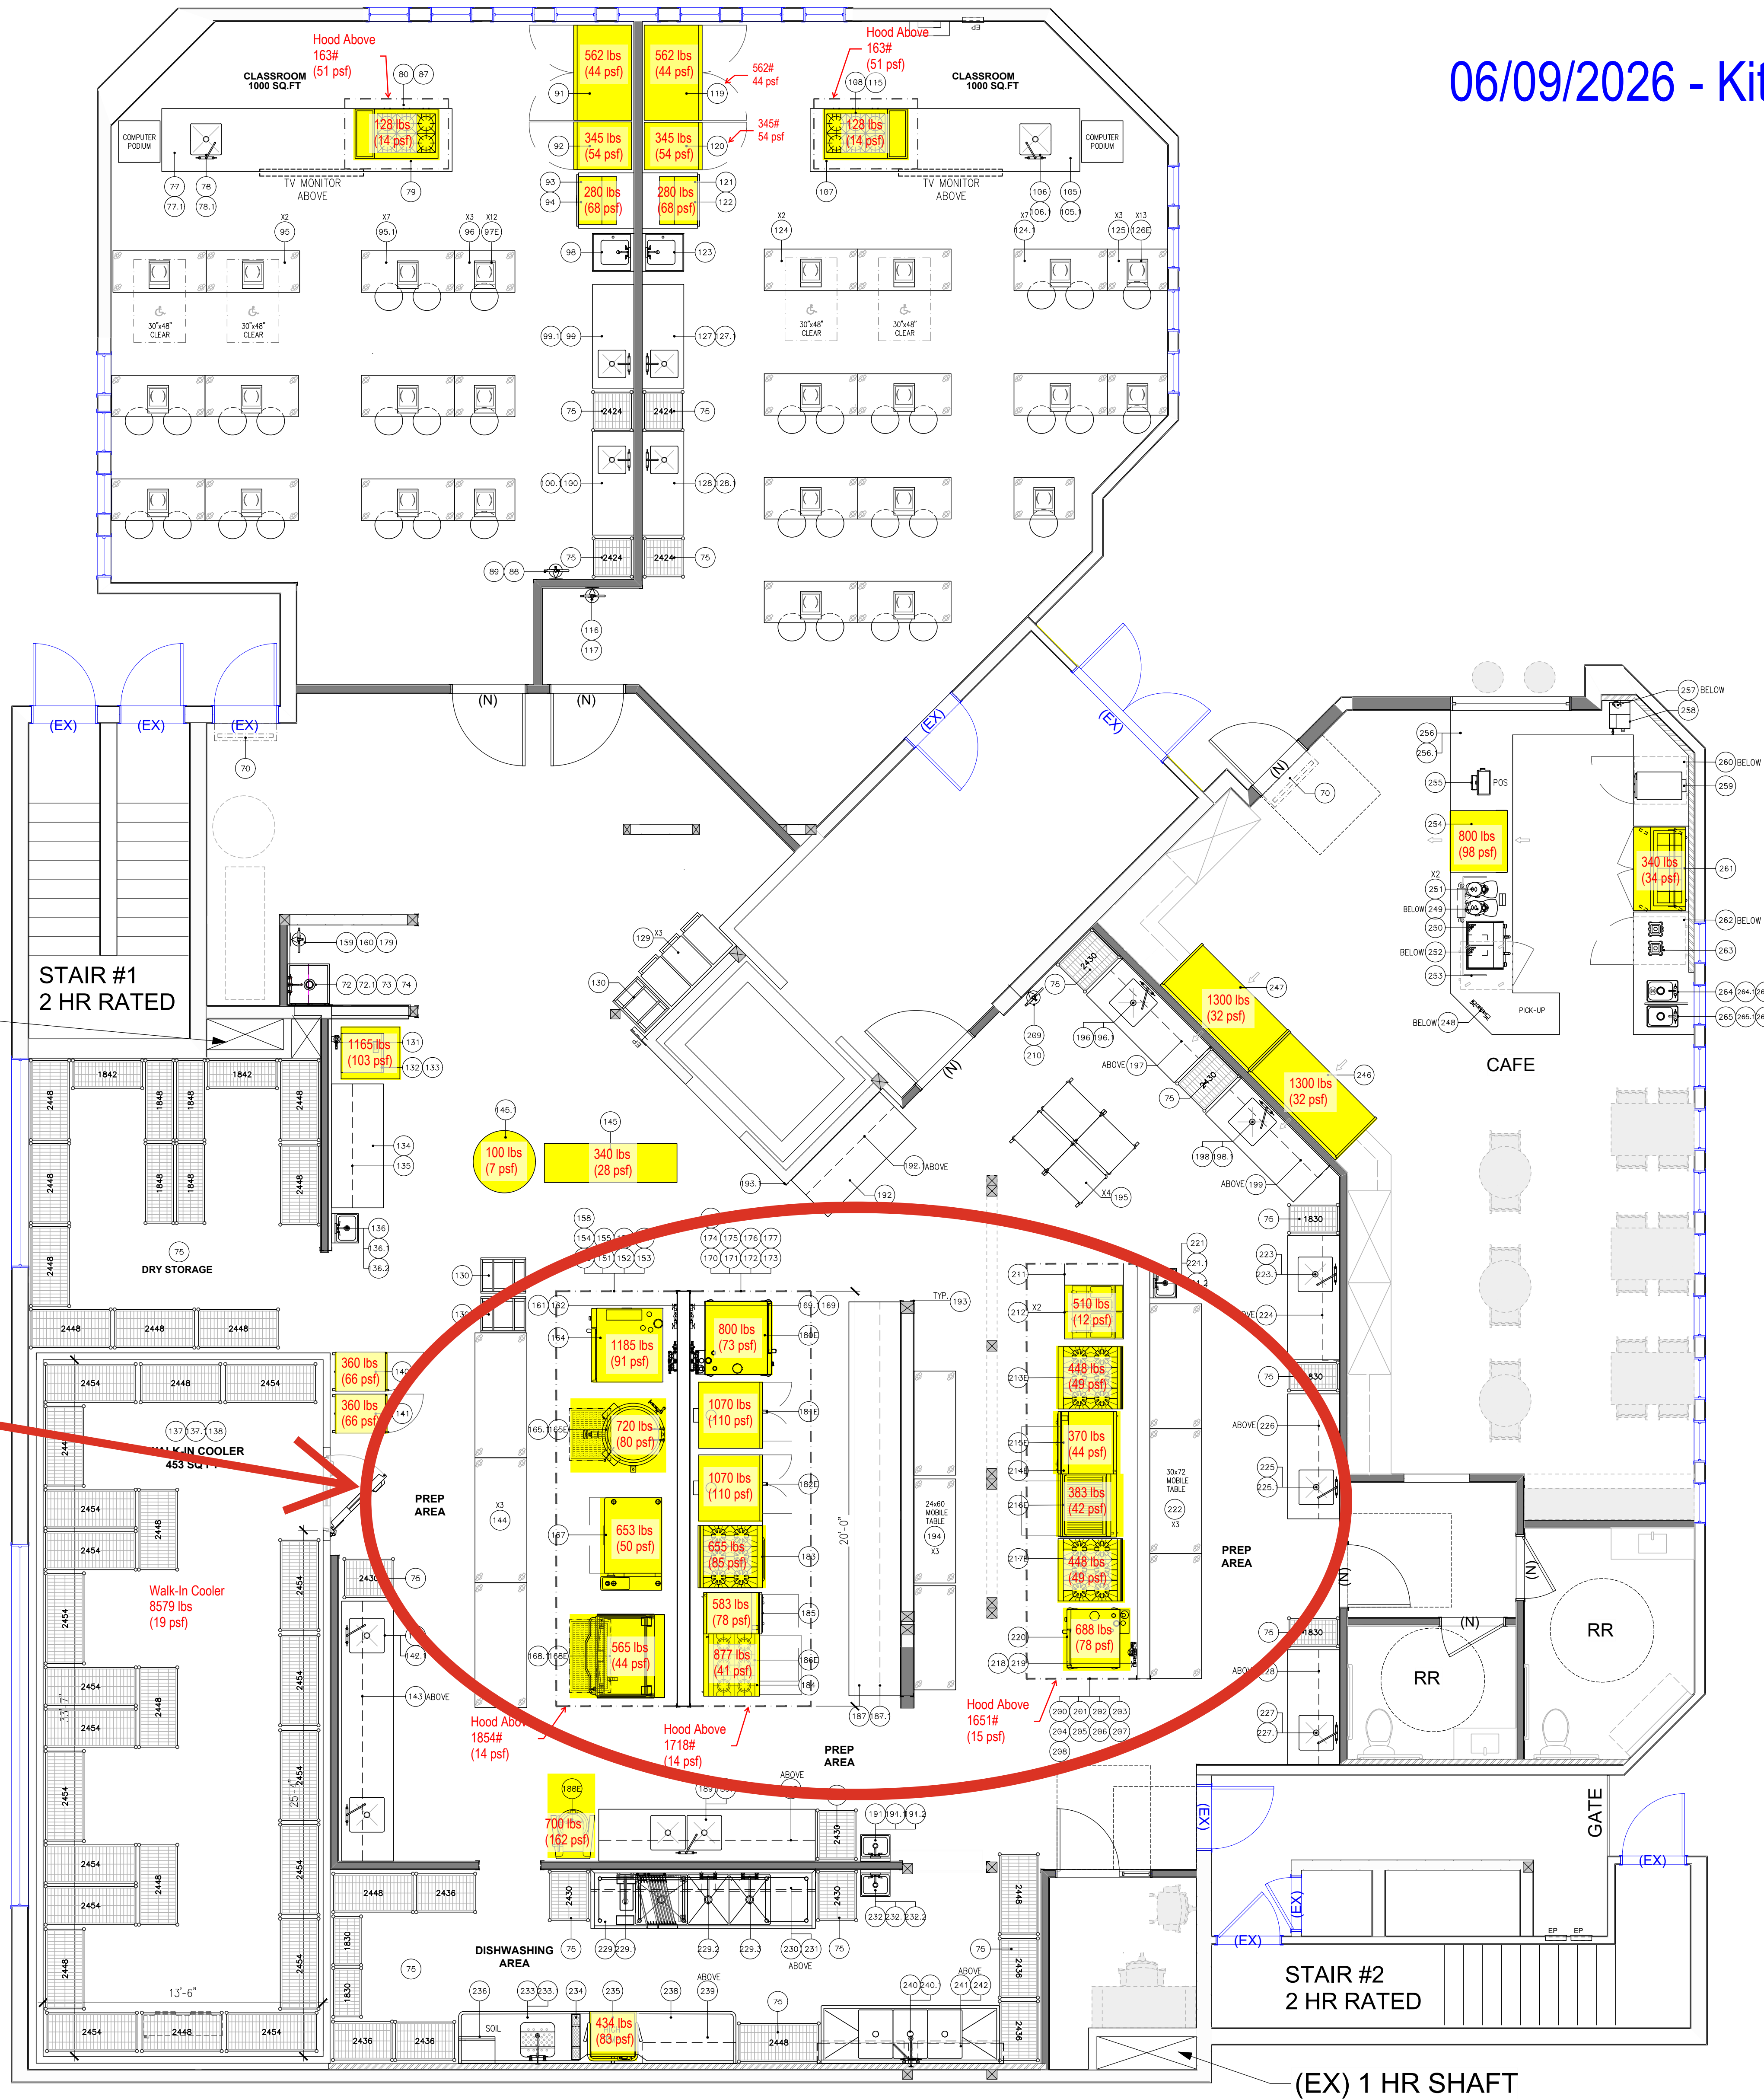
K102

NOTE: These drawings do not yet reflect the 50% reduction of hood length required for structural modifications

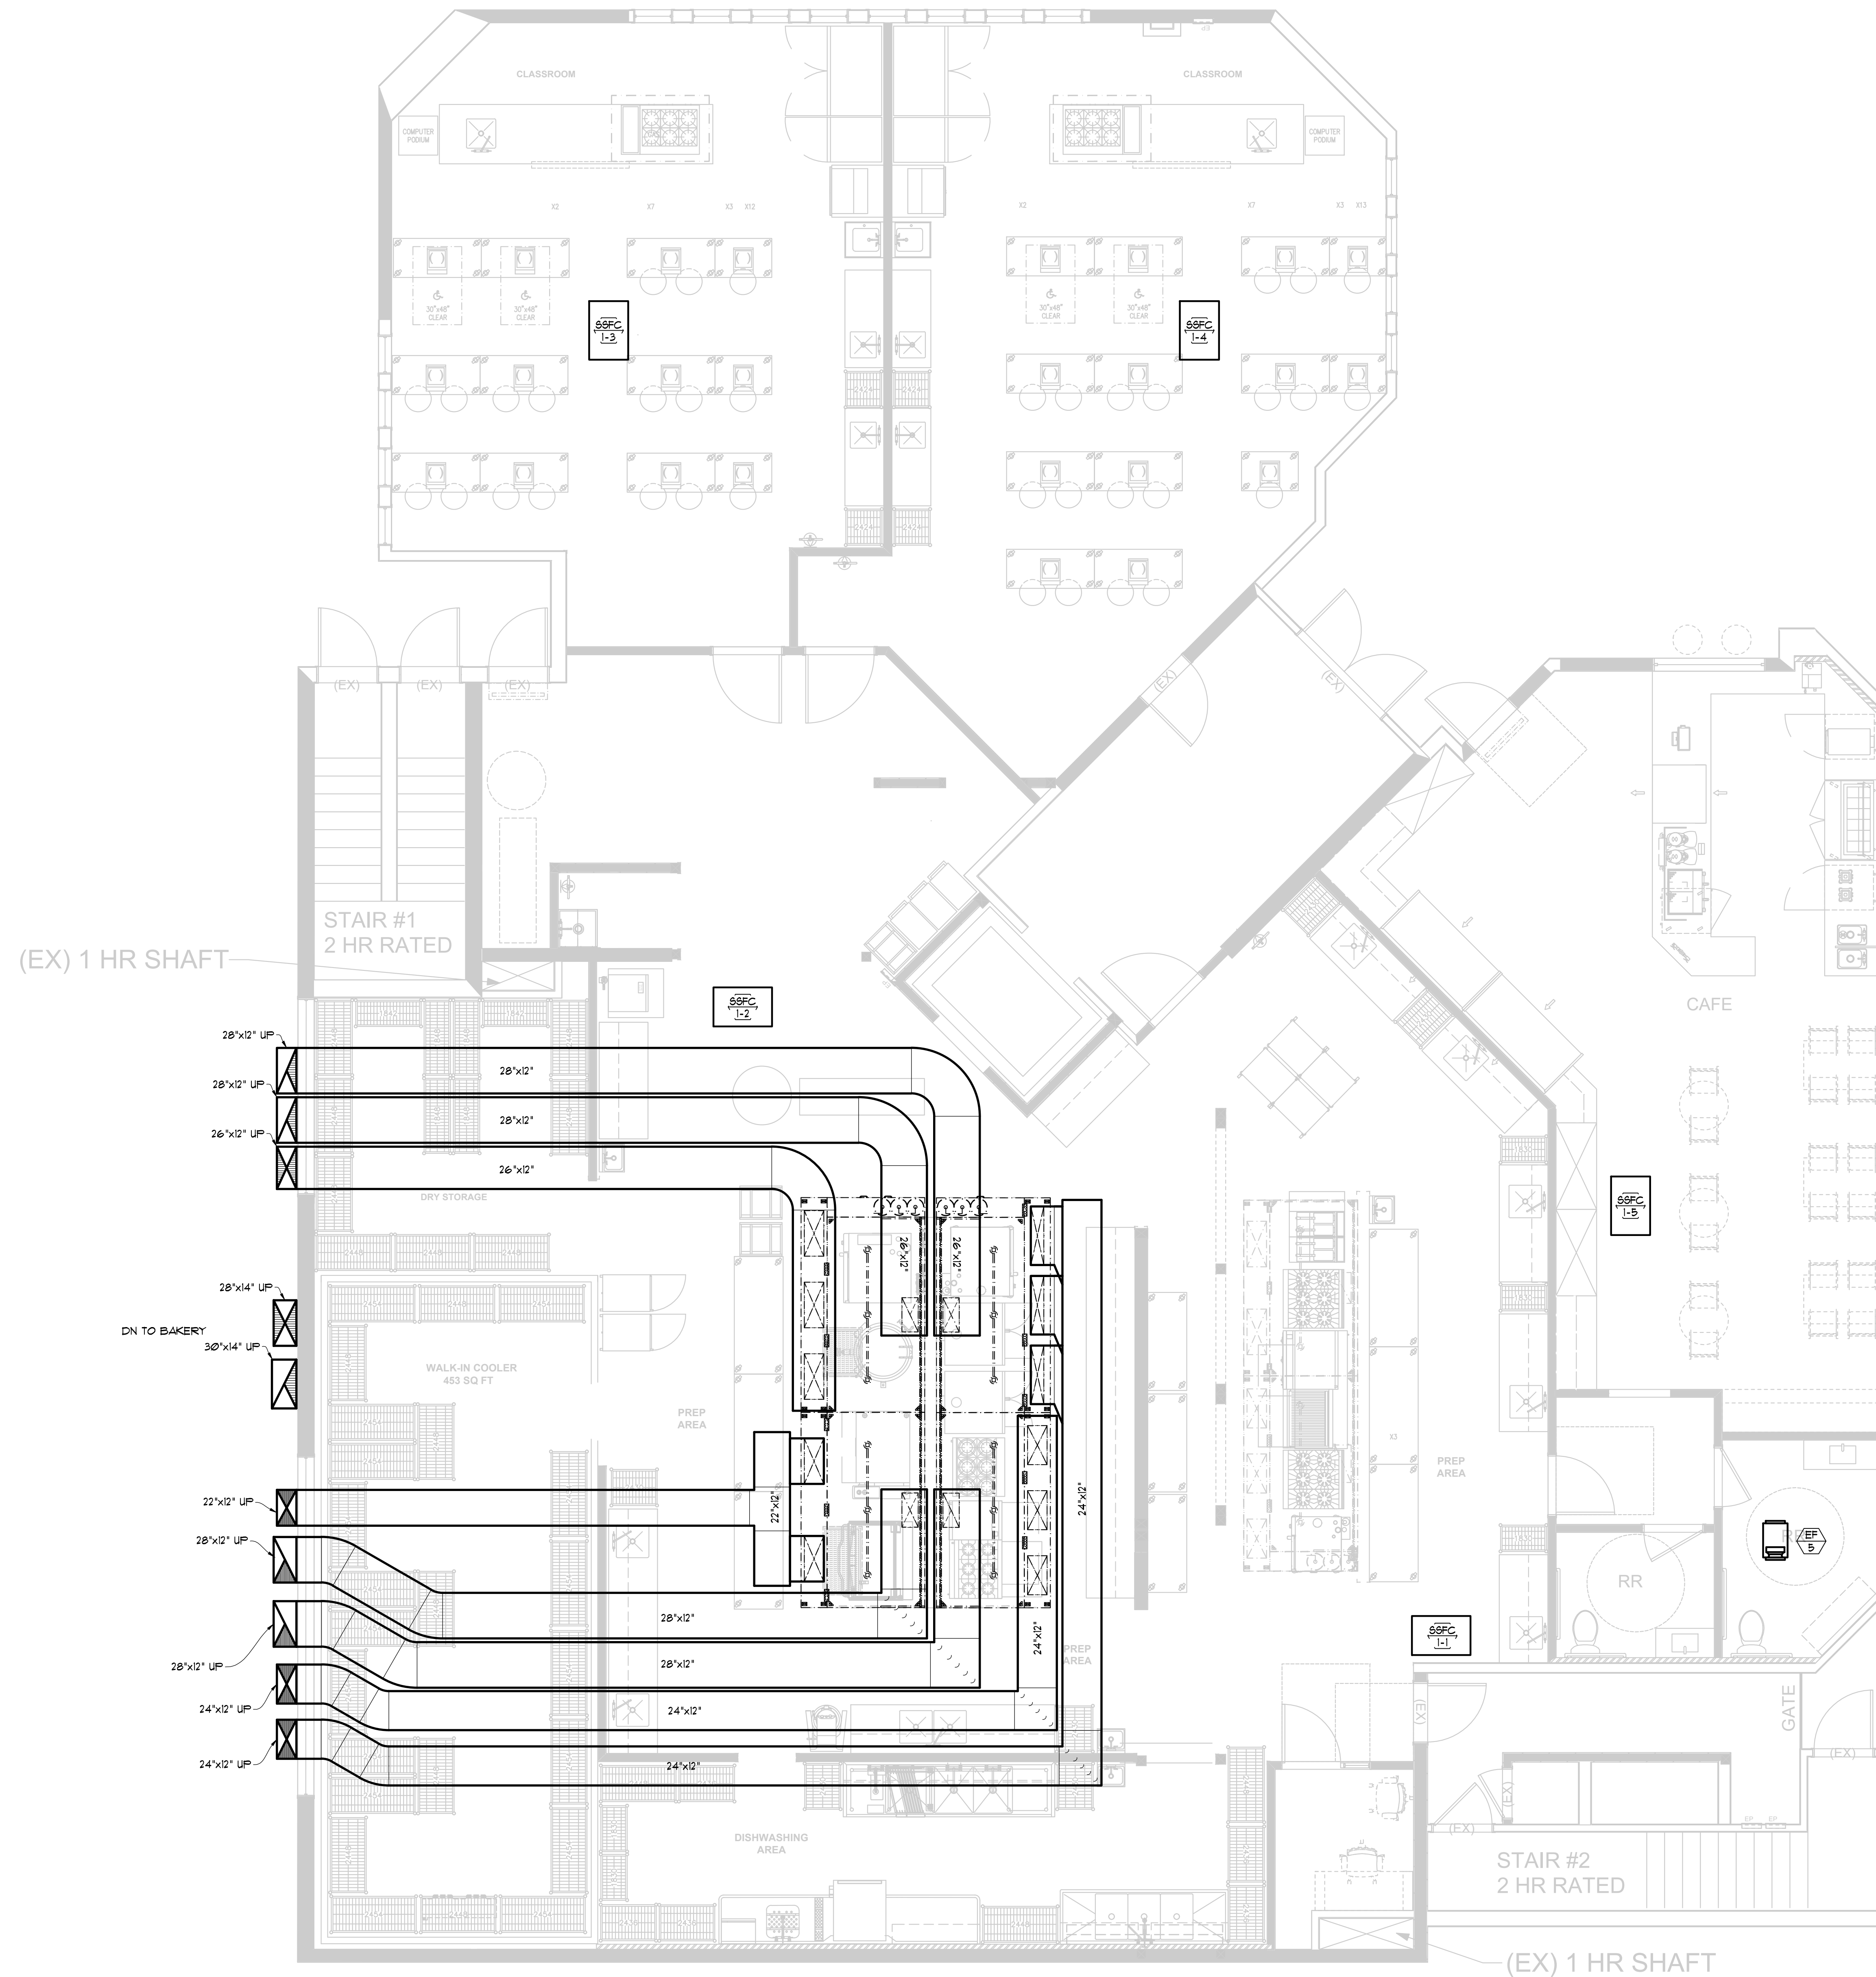
M202

MECHANICAL NEW WORK FIRST FLOOR PLAN

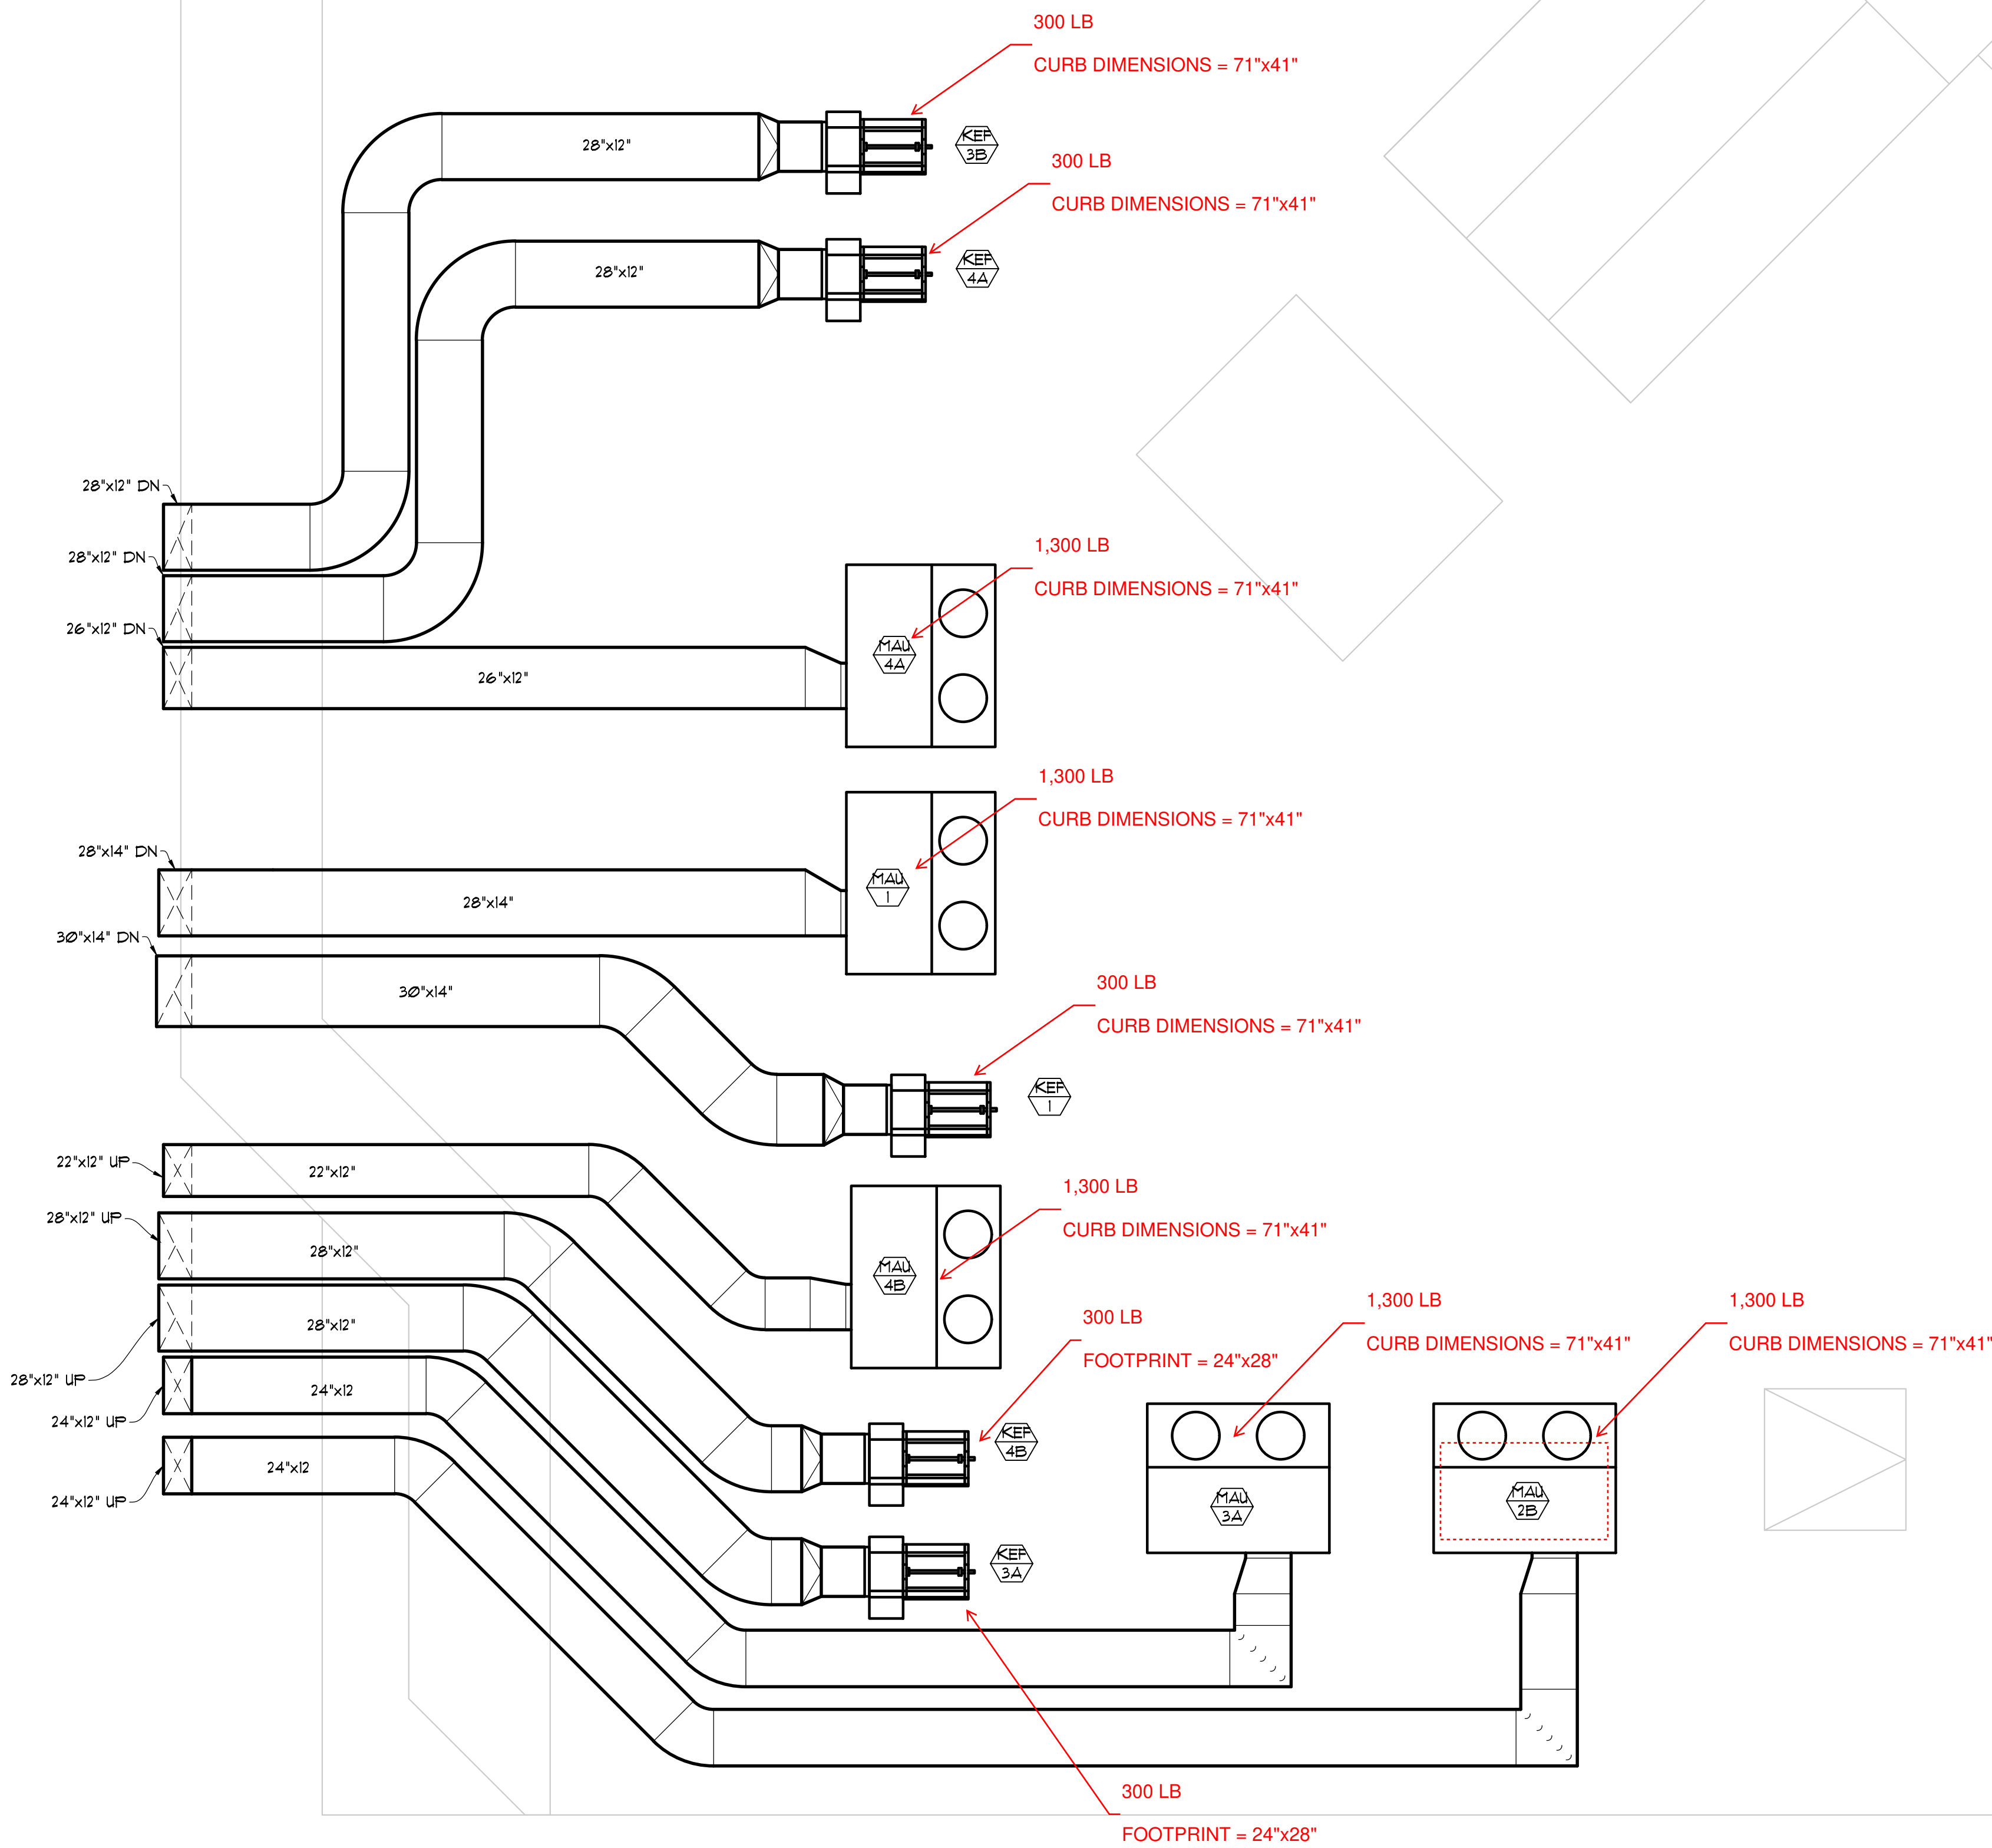
M205

MECHANICAL NEW WORK ROOF PLAN

- The roof consists of plywood deck over 28" TJLX joists spaced at 24 inches on center.
- Proposed MAUs and KEFs will be supported on the roof deck. The as-built drawings state the roof live load allowance is 20psf. The uniform weight of the rooftop equipment is approximately 64psf.
  - The current placement of the units at the midspan of the members creates worst case flexure in the existing joists, which exceeds the capacity of the existing joists. This will require replacement of the existing wood truss joists in the southwest quadrant of the roof, from approximately grids 4-6 between grids B-D. The roof is supported by transfer columns and beams at the third level, see “Third Floor Deck” for proposed enhancements.
